5 Peatland biodiversity

6 Planning peatland restoration projects

7 Restoration work

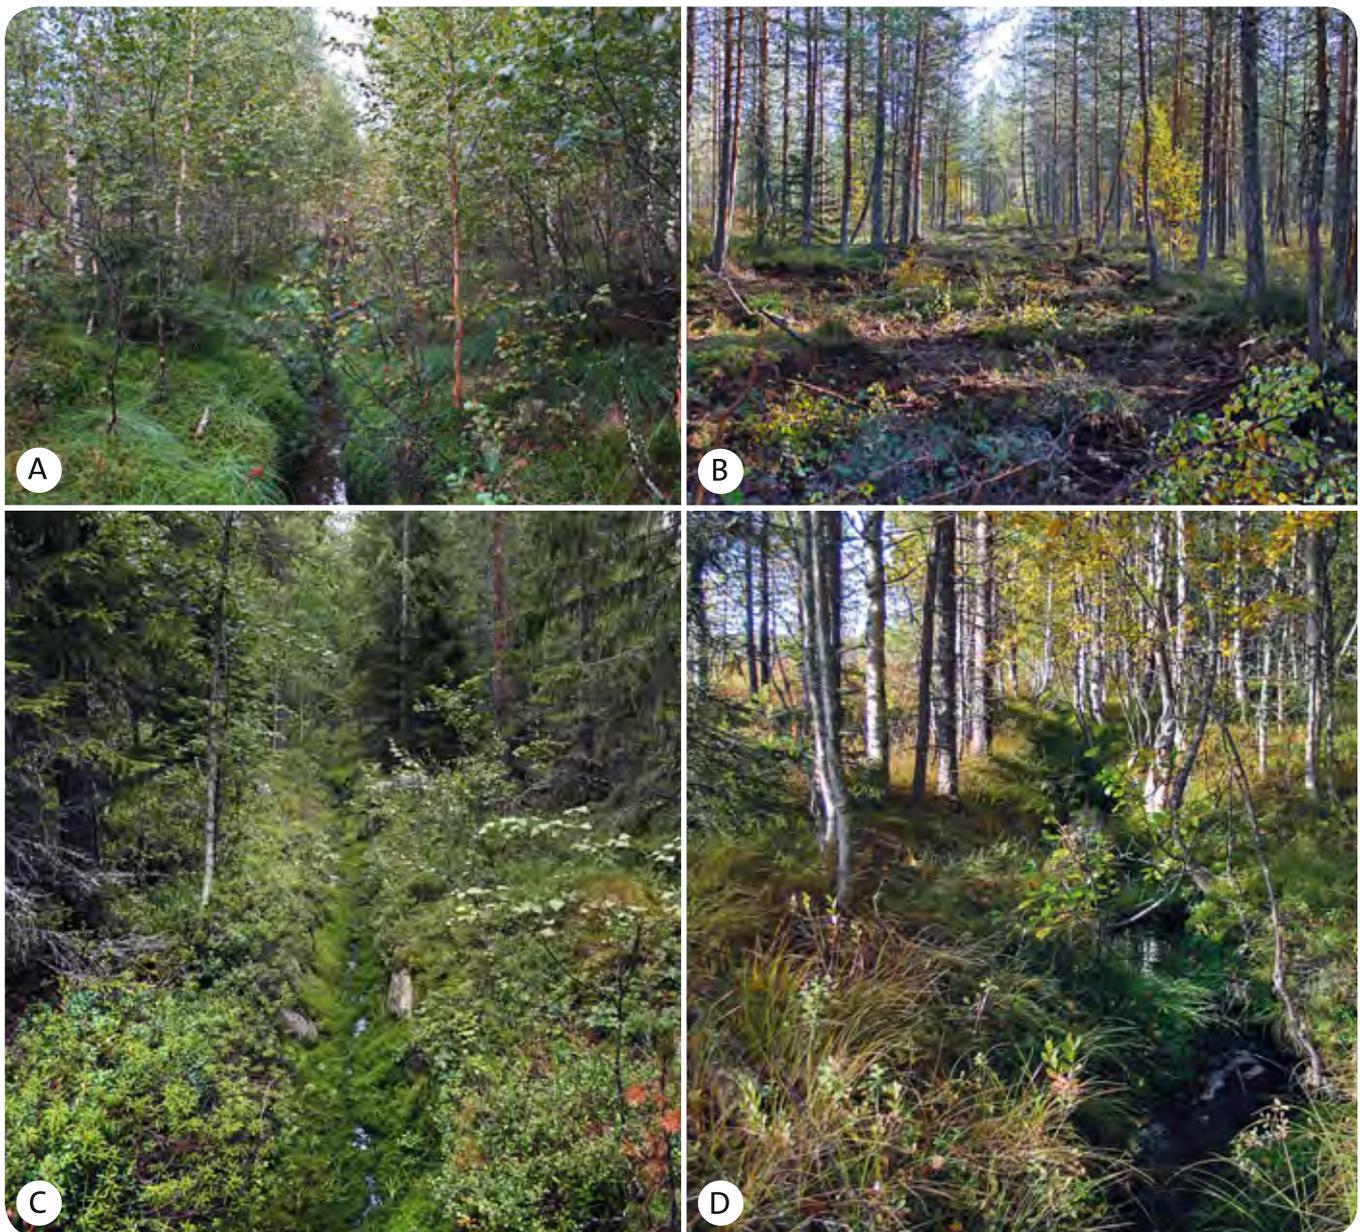
Figure 27. Even where small trees grow densely (A) this should not normally hinder mechanical infilling. Photo B shows a stretch of the same ditch after restoration where trees were not cleared alongside the ditch. Clearing is usually not needed along ditches by which only a few larger trees grow (C); though trees thicker than a man's arm that consolidate the spoil excavated from a ditch often need to be cleared (D). PHOTOS: SUVI HAAPALEHTO (A, B, D) AND MAARIT SIMILÄ (C).

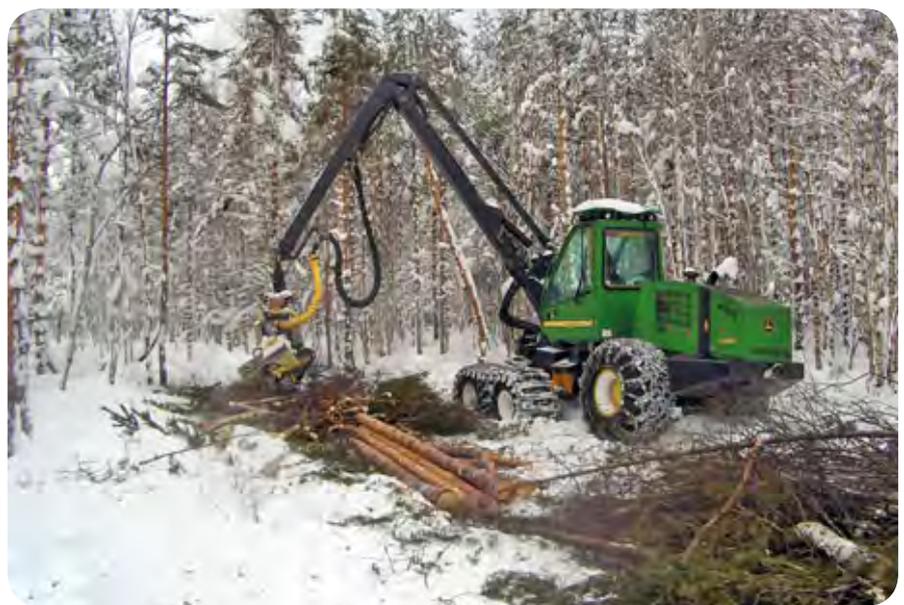
Figure 29. This multi-purpose forestry machine is starting to remove trees from a peatland site that would naturally be open. It has also piled up logging residues including branches, which in this case will also be removed from the site. PHOTO: PEKKA VESTERINEN.

Trees are usually removed mechanically from a peatland site to be restored (Figure 29) before ditches are blocked, since at this stage the site conditions are drier than they will be later. Mechanised tree harvesting requires solid ground, and is usually only possible in winter when the surface of the peatland is frozen. Lighter forestry machines fitted with caterpillar tracks suitable for peatland conditions are most commonly used.

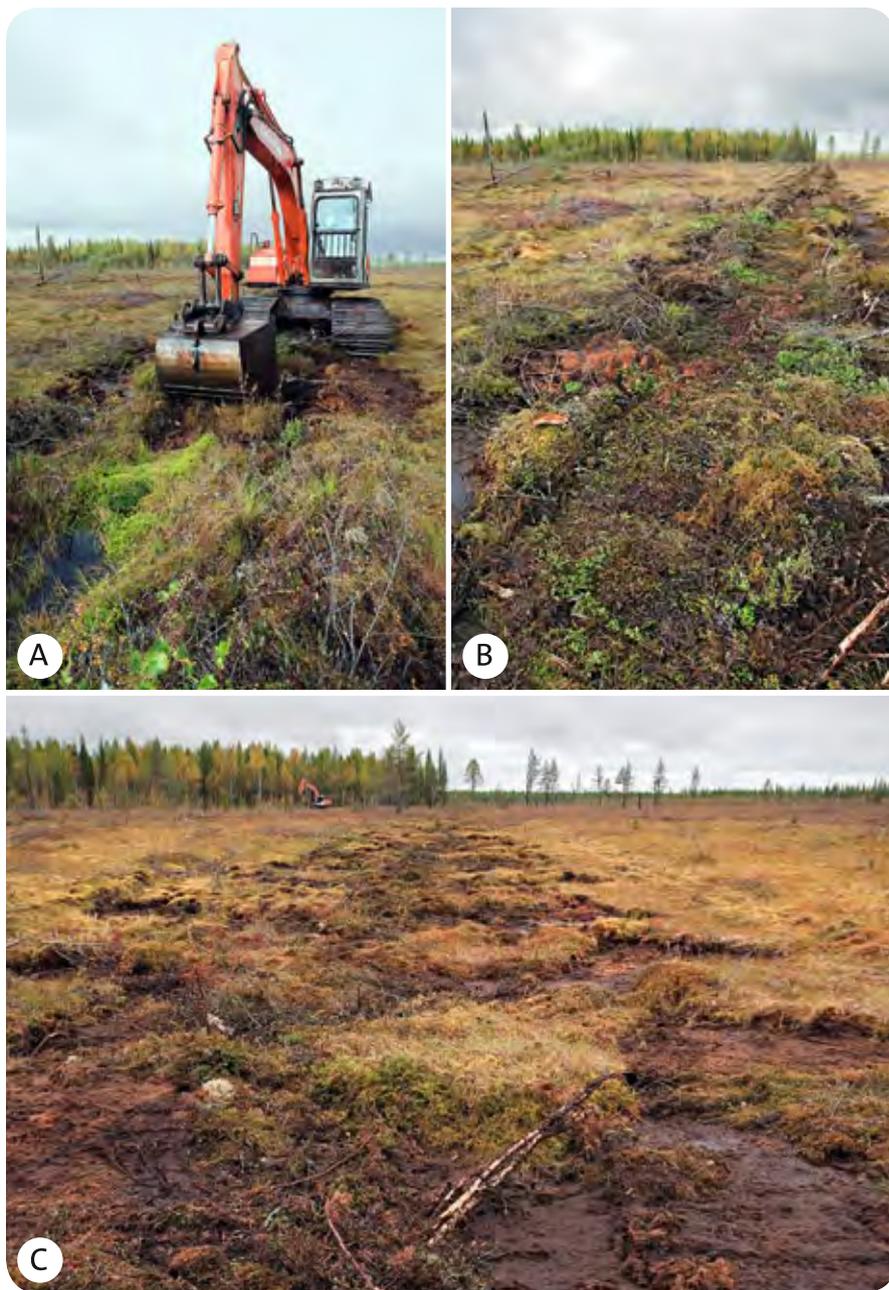
Figure 30. (A) The excavator driver filled in this ditch by driving up and down its entire length. On the outward journey he filled in the ditch compactly (B); and on the return journey he completed the peat embankments and channels for water (C). Trees had been felled in this naturally open peatland site during the previous winter. PHOTOS: PHILIPPE FAYT.

Hydrological conditions are most cost-effectively restored by infilling and damming ditches with an excavator (Figure 30). The peat used to dam or infill

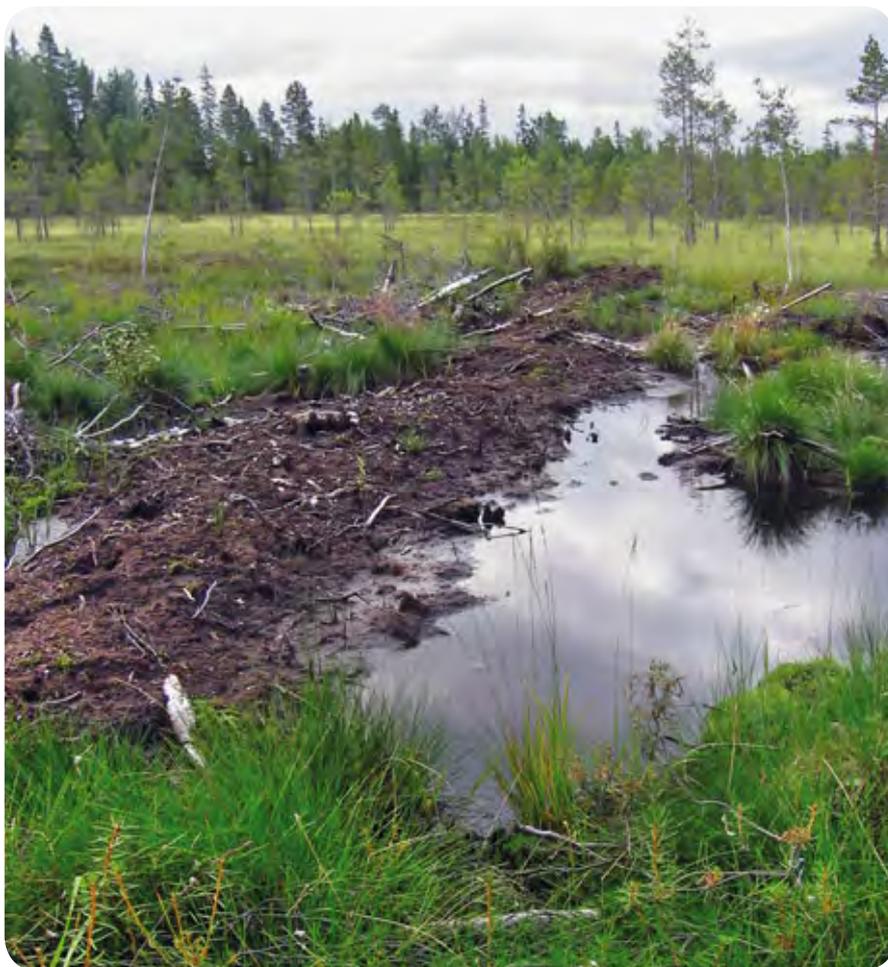
Figure 31. In this wet fen the courses of ditches remained below the level of the surrounding peatland even after infilling, so plenty of water still accumulated along the old ditch lines. As this had been anticipated, peat embankments were created at short intervals to spread the water more widely over the peatland. The direction of water flow is from right to left. PHOTO:

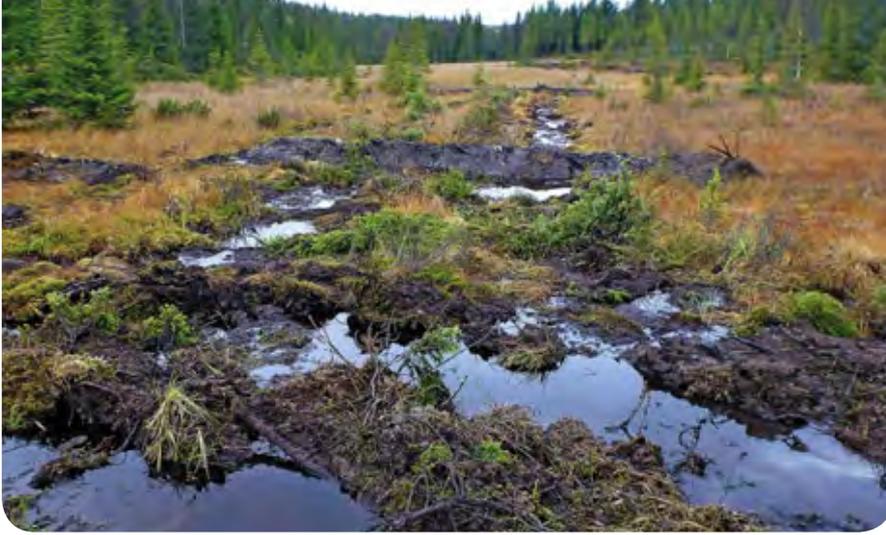
Figure 32. In wet sloping peatlands peat embankments are particularly important, since they help water to spread over the peatland rather than continuing to flow along the courses of infilled ditches. PHOTO: ULLA AHOLA.

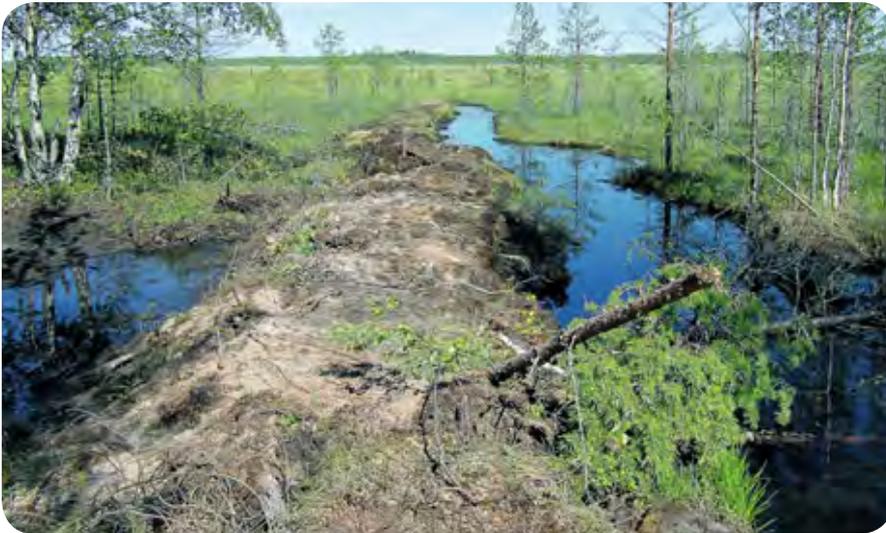
Figure 33. It may be worth making very long peat embankments in key locations with regard to water flows. In this site embankments were about 60 metres long. The dimensions of the embankments were clearly marked in the field with ribbons to ensure that the excavator driver made them long enough. This photograph was taken from the site of the infilled ditch, where water earlier flowed from right to left. The embankment was made perpendicular to the ditch line. A channel formed where peat was dug up to make the embankment, and water now flows along this channel to feed areas of flark fen which had not been drained but had nevertheless dried out. PHOTO: REIJO HOKKANEN.

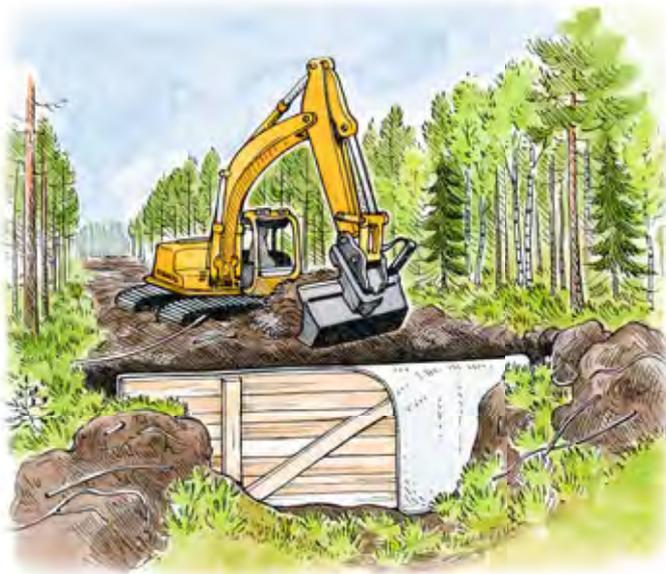
Figure 35. Tongue-and-groove boards can be used to help make dams in large or badly eroded ditches. The geotextile used to cover the boards is only partly shown in these illustrations to enable their underlying structures to be seen. Illustrations: Tupu Vuorinen.

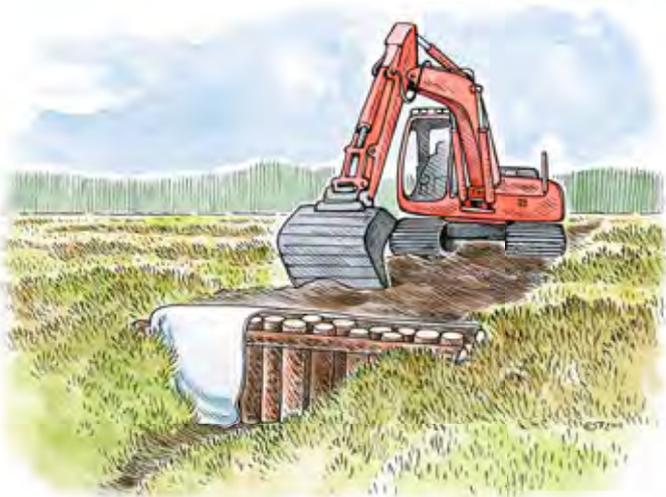
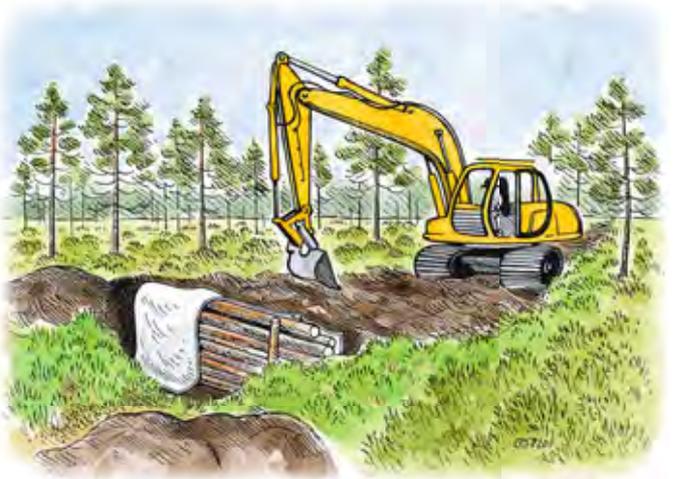
Figure 36. Log dams may be constructed where suitable logs can be cut from trees felled on the site. The top ends of the logs should stand out clearly above the level of the ditch banks. If the peat is deep, the logs can be sunk vertically into the peat, but where peat deposits are only shallow the logs can be put in place horizontally. The dam should then be covered with geotextile and peat. Log dams can be further stabilised with the help of supporting logs aligned at right angles to the other logs. ILLUSTRATIONS: TUPU VUORINEN.

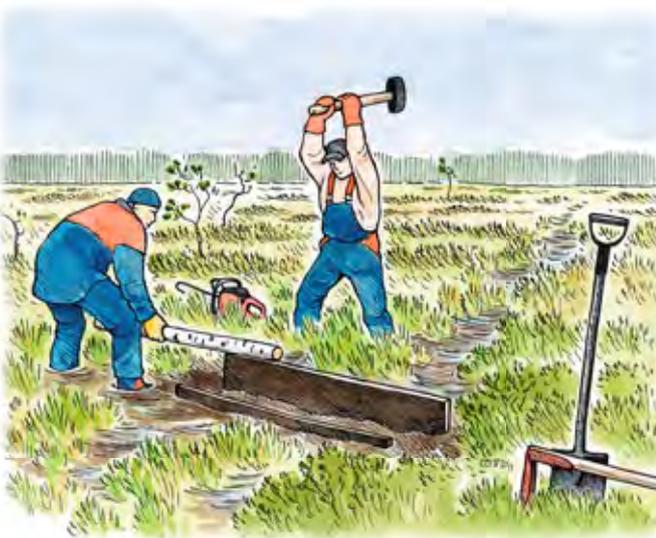
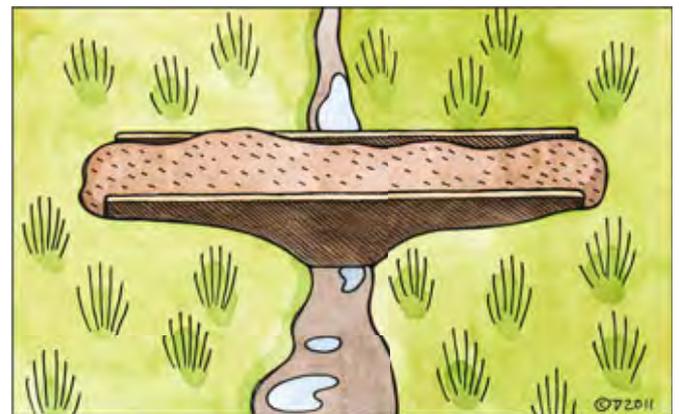
Figure 39. Dams made of plywood can be used to block shallower ditches. Board should be sawn to sizes with greater length and depth than the ditch. To put them in place grooves can be cut in the peat using a long-reach motor-saw. The boards can then be hammered into place e.g. with a sledgehammer. Peat should then be shovelled in between the boards and packed tightly. ILLUSTRATIONS: TUPU VUORINEN.

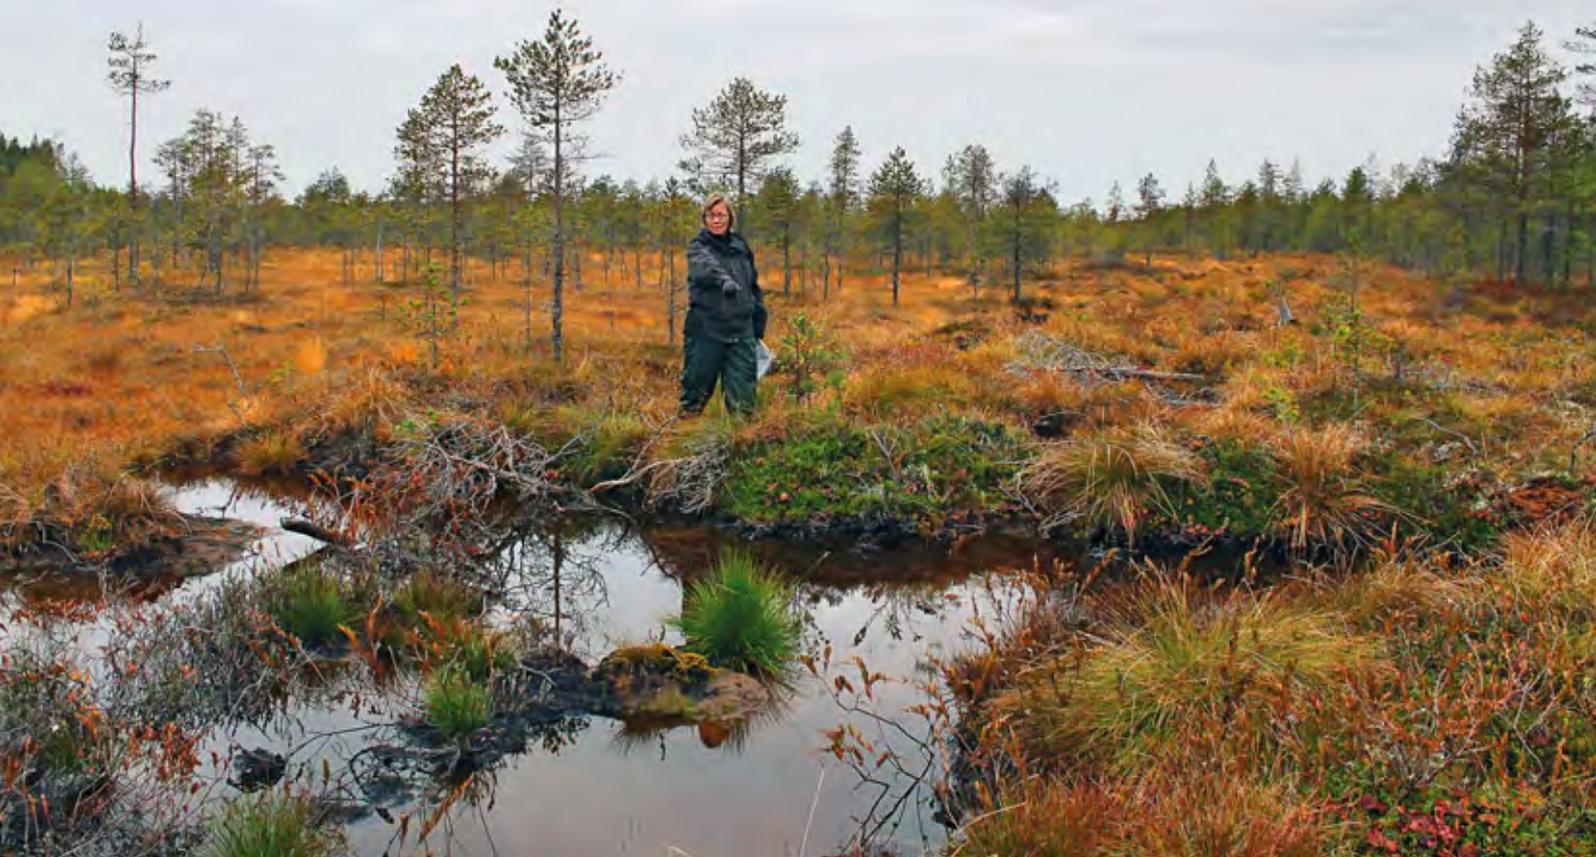
Figure 46. A general monitoring visit to this peatland site, restored five years previously, reveals that a dam has functioned well. PHOTO: MAARIT SIMILÄ.

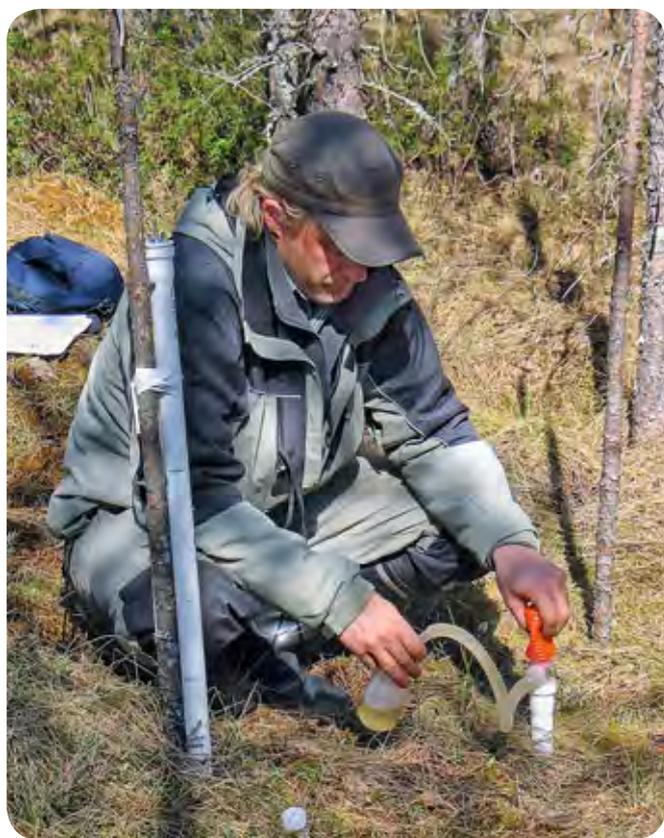
Figure 47. Data obtained by analysing water samples is used to assess hydrological changes following restoration, and how they differ between different types of peatland. PHOTO: MAARIT SIMILÄ.

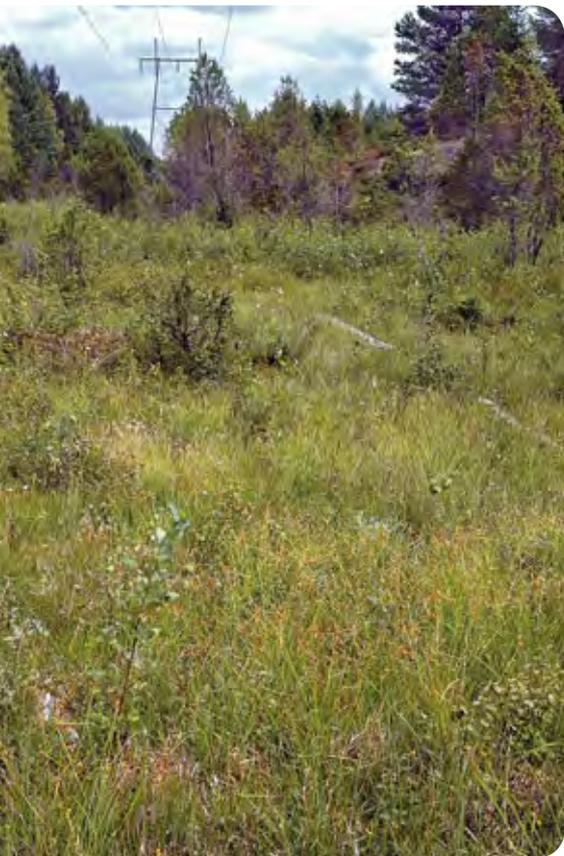
Figure 51. *Carex flava* and *Trichophorum alpinum* most clearly benefited from restoration in the margins of the fen that had not been so affected by drainage, which had also been kept open beneath the power line.

in the southwest corner, and the catchment area is large in relation to the extent of the fen itself (Figure 50). In the parts of the mire above intercepting ditches the positive impacts of restoration soon became evident (Figure 51). When ditches were dammed the spring water discharge effectively rewetted the dried out surfaces of the marginal fen, and the struggling fen vegetation recovered rapidly. For instance, only a few withered shoots of *Scorpidium scorpioides* had earlier been found, but the species soon proliferated over an area of ten square metres, accompanied by other species including *Scorpidium revolvens* and *Campylium stellatum*. Species associated with springs also thrived, while conversely species more associated with drier calcium-rich growth sites, such as the moss *Thuidium recognitum*, declined.

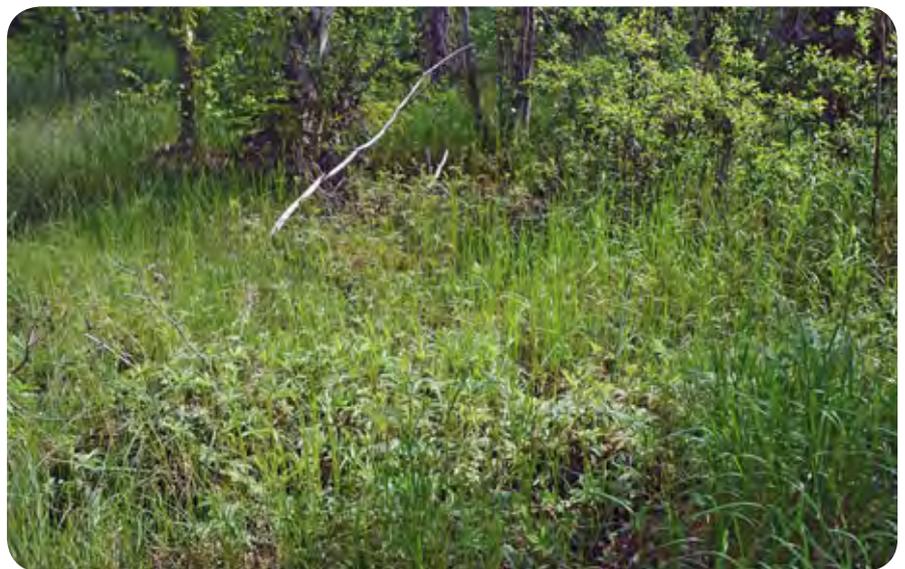
Figure 52. After restoration the most affected central parts of the site were taken over by grasses, herbaceous plants and sedges indicative of nutrient-rich and swampy conditions.

and therefore most radically altered by drainage, now consists of tall grasses, tall sedges and swampy spruce mire with sedges (Figure 52). Abundant species include *Lysimachia thyrsiflora*, *L. vulgaris*, *Viola palustris*, *Carex cespitosa*, *C. elongata*, *C. rostrata* and *Pedicularis palustris*. Thickets have been kept under control, and rising water levels have thinned out tree cover.

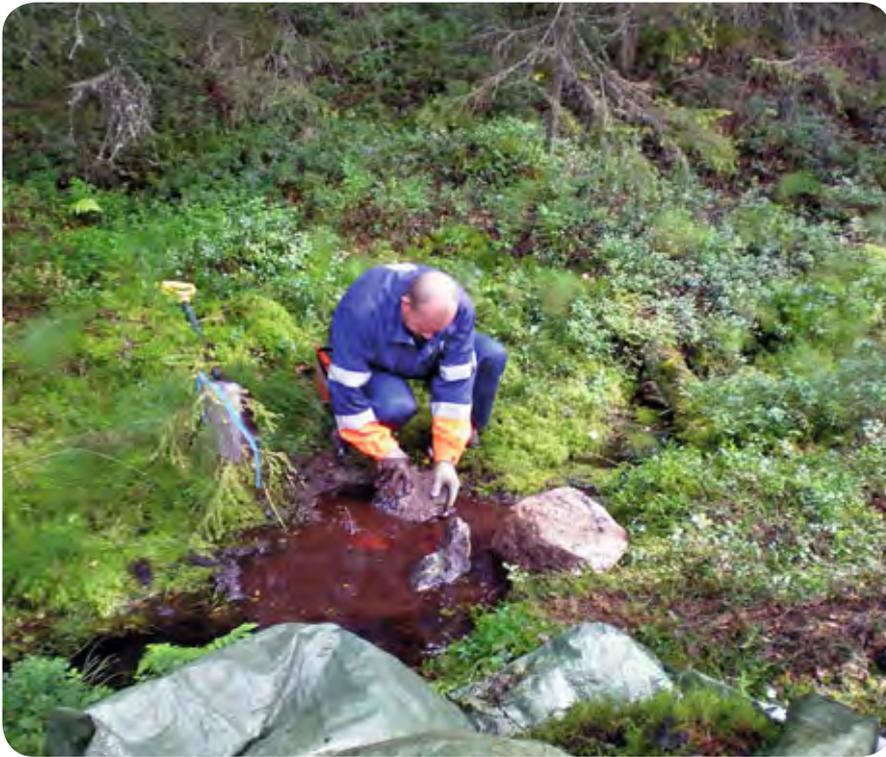
Figure 54. The water level in this spring was raised with the help of a small weir built about two metres away. Spring mosses were lifted out of the stream onto a tarpaulin for protection during restoration work. The water level eventually rose by about 5 cm. PHOTO: SARI KAARTINEN.

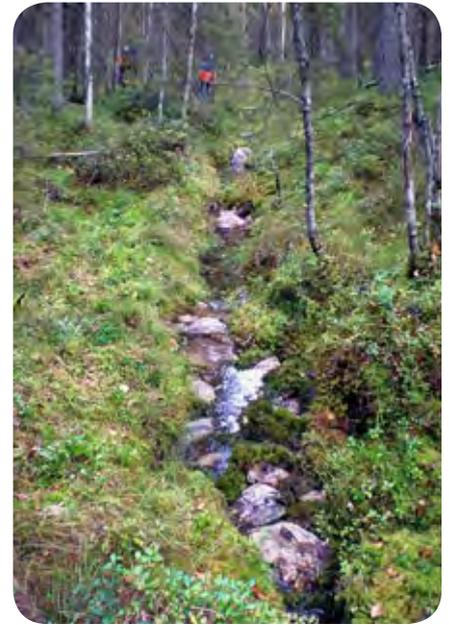
Figure 55. Previously spring-fed water flowed deep in the ditch bottom and was hardly visible. Weirs were built to slow the flow and create pools of calmer water and small waterfalls. By calmer pools mosses can proliferate on stone and wood surfaces. PHOTO: SARI KAARTINEN.

In 2010 water flow rates in the ditches slowed, and wider areas were affected by spring-water. Weirs made of stones, tree trunks and jute sacks filled with peat were built to raise water levels and spread the spring-water further. At the same time the ditches became more like natural streams (Figure 55). While the weirs were being constructed, mosses dependent on spring-water were lifted out of ditches to protect them (Figure 81). Stones earlier removed from ditches were rolled back into them, and the spring-water-dependent moss growths were transplanted onto stone or wood surfaces at a suitable height to enable them to continue growing. The aim was not to completely infill the ditch, but to carefully raise water levels in the surrounding spruce mires, and to make the channel where the groundwater now flows more natural (Figure 55).

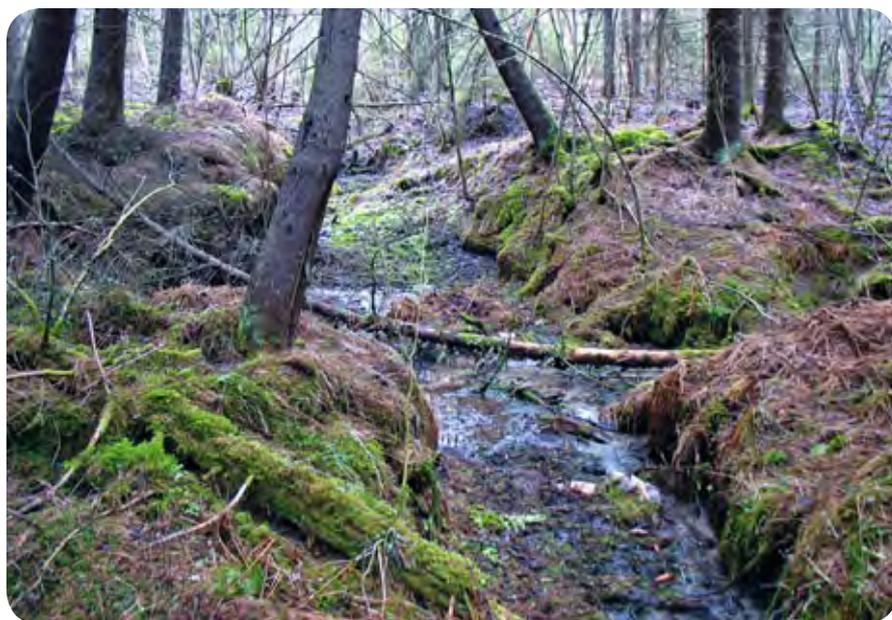
Figure 57. Groundwater is discharged here into the middle of a ditch. PHOTO: REIJO HOKKANEN 2007.

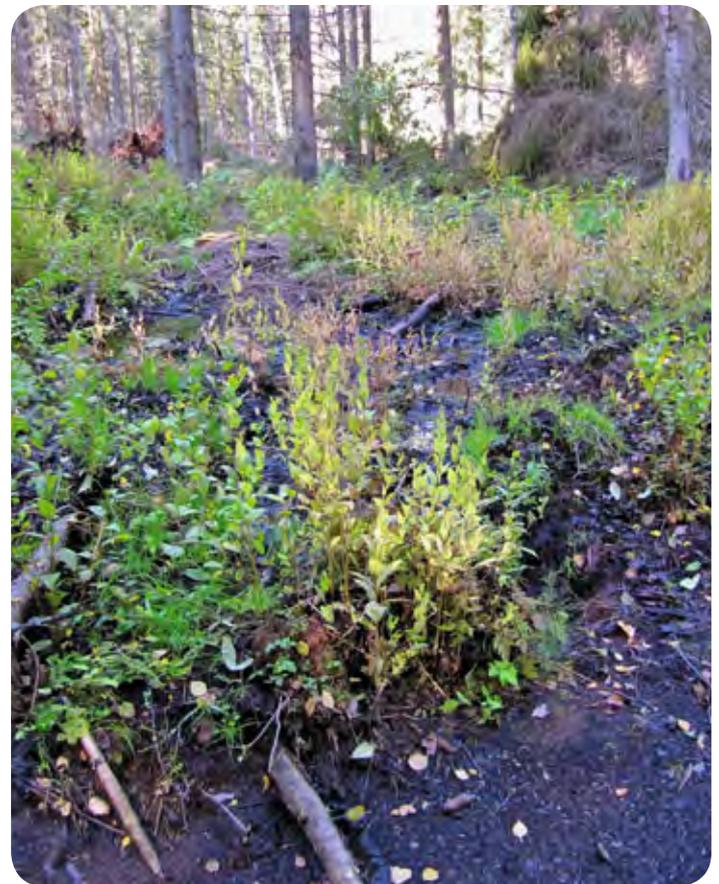
Figure 59. *Impatiens noli-tangere* took over ditch lines after restoration, and many trees fell during a storm in July 2010. PHOTO: REIJO HOKKANEN.

ditches unevenly had evidently helped to prevent the transportation of suspended solids, since water was only meandering slowly through the infilled ditches. *Impatiens noli-tangere* had clearly proliferated since the first summer due to the increased availability of light, having taken over areas of bare ground along ditches and where trees had been felled (Figure 59).

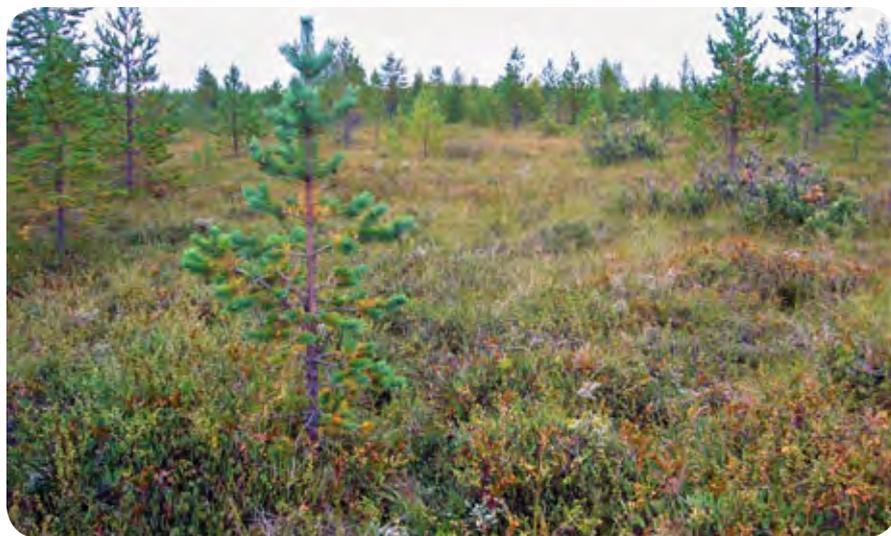
Figure 61. Vegetation growing in a former flark fen which though undrained had been badly dried out by a drainage channel located about 200 metres to the east. Photo: Päivi Virnes, August 2006.

This drainage channel also dried out large parts of the undrained aapa mire lying just west of the channel. As far as 500 metres west of the channel pine seedlings and dwarf birch were found growing in areas that had earlier been wet flark fen (Figure 61). The flarks had dried out, their vegetation had become more uniform, and the significance of the whole peatland area as a breeding and resting area for birds had declined.

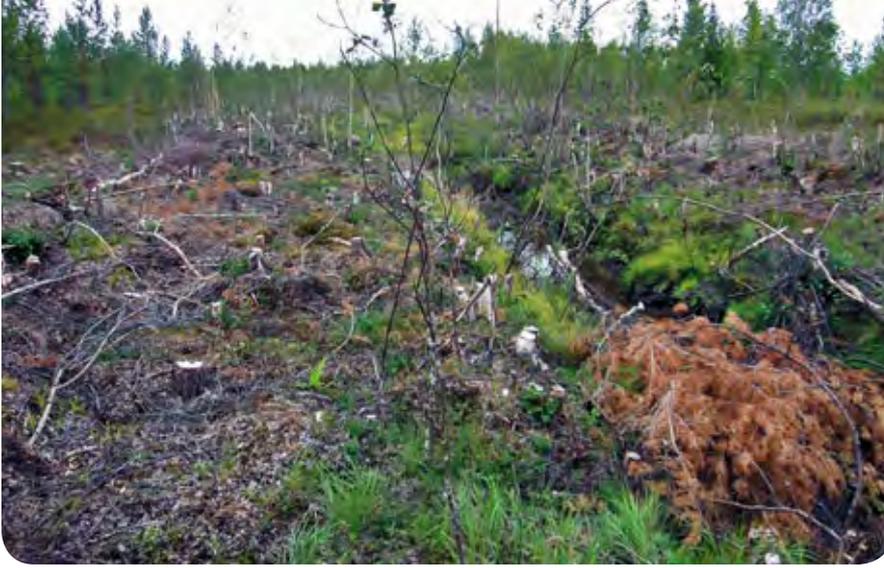
Figure 64. The scene in the cleared belt alongside the main drainage channel during the dry summer of 2006, before it was blocked. PHOTO: PÄIVI VIRNES, AUGUST 2006.

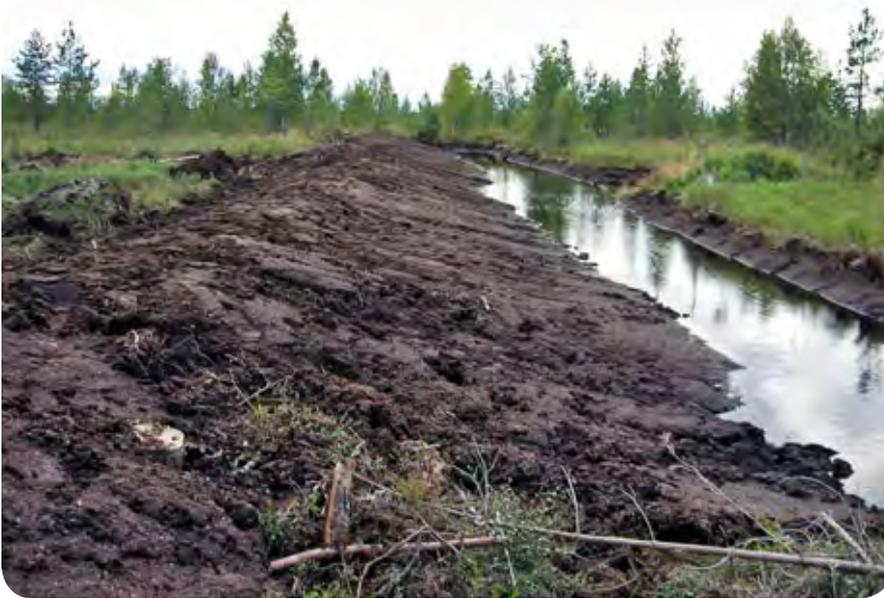
Figure 65. This peat embankment was constructed a couple of weeks before the photograph was taken. The pools excavated alongside have not yet filled with water. PHOTO: PÄIVI VIRNES, AUGUST 2007.

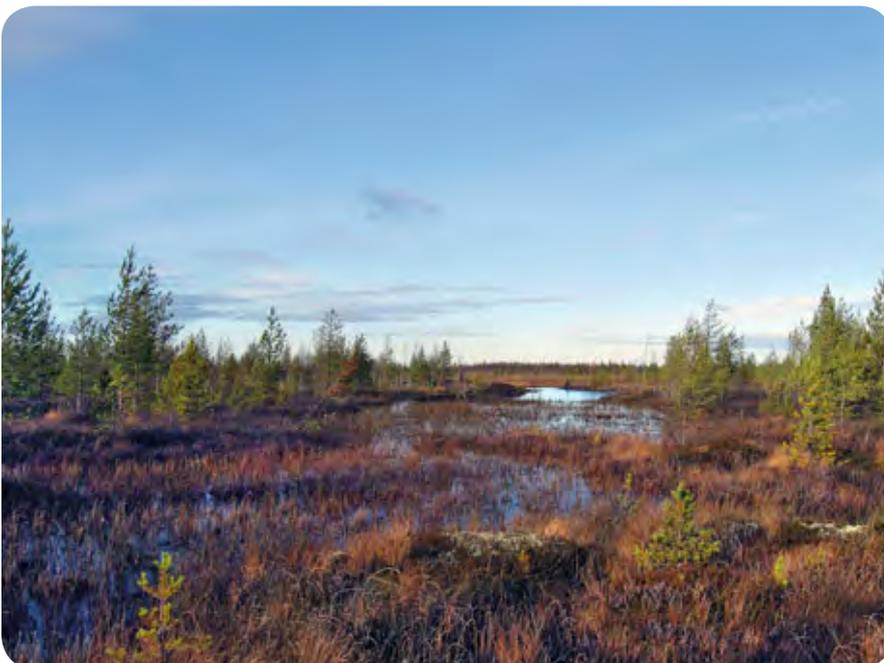
← **Figure 66.** The view over the restored drainage channel looking west towards the centre of the open peatland, about a year after restoration measures were realised. The aapa mire is no longer drying out, and flarks are filled with water again. PHOTO: SAKARI REHELL, JULY 2008.

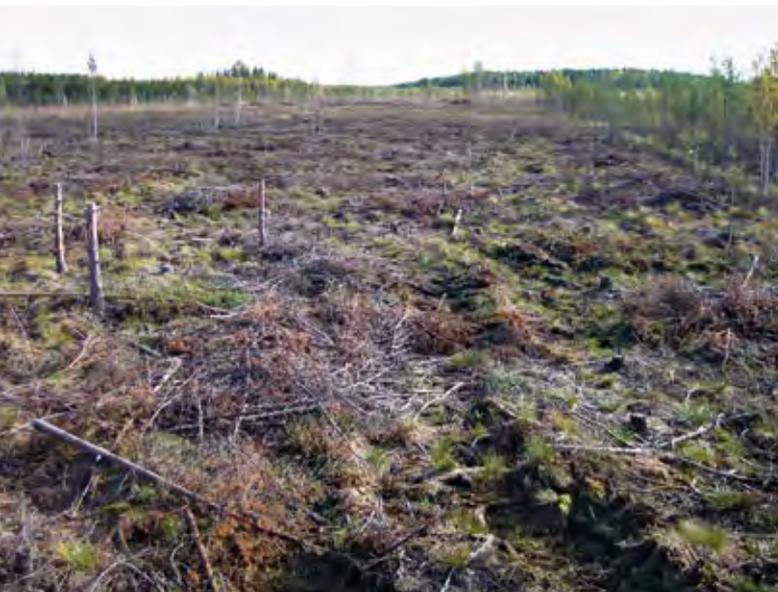
Figure 75. The ditches south of Vuosiaissalo in September 2009. The trees had been felled during the previous winter, and the ditches had not yet been blocked. PHOTO: REIJO HOKKANEN.

Restoration work commenced in February 2009 with tree felling (Figure 74). All of the pines that had grown after drainage ditches were dug in an area of 17 ha on either side of Vuosiaissalo were felled for sale as pulpwood or energy wood (Figure 75). A forestry machine was used, though some trees were felled manually. Birches were left standing to prevent the sprouting of thickets.

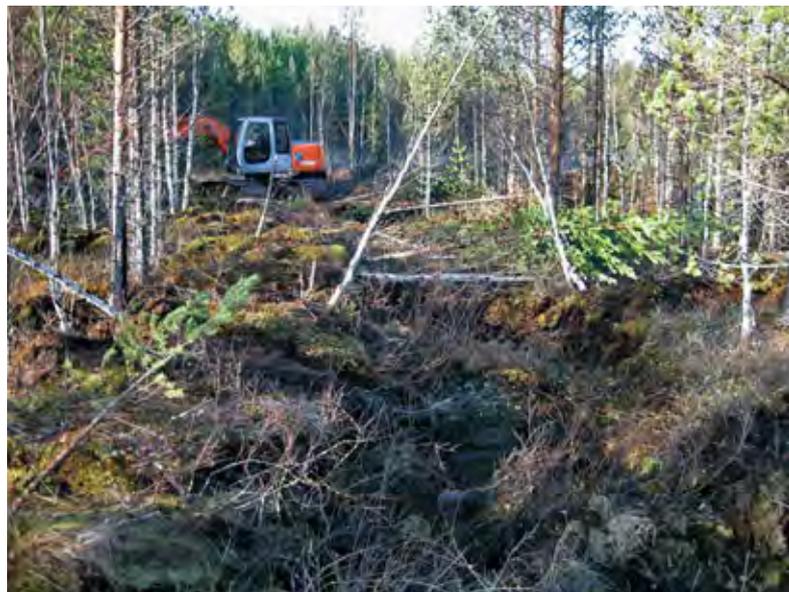
Figure 76. An excavator building a long dam in the main ditch in the drained area north of Vuosiaissalo, October 2009. By the excavator the ditch is near the boundary of an adjoining area with mineral soil. The forest behind the excavator is part of Vuosiaissalo. The water flows from right to left. PHOTO: REIJO HOKKANEN.

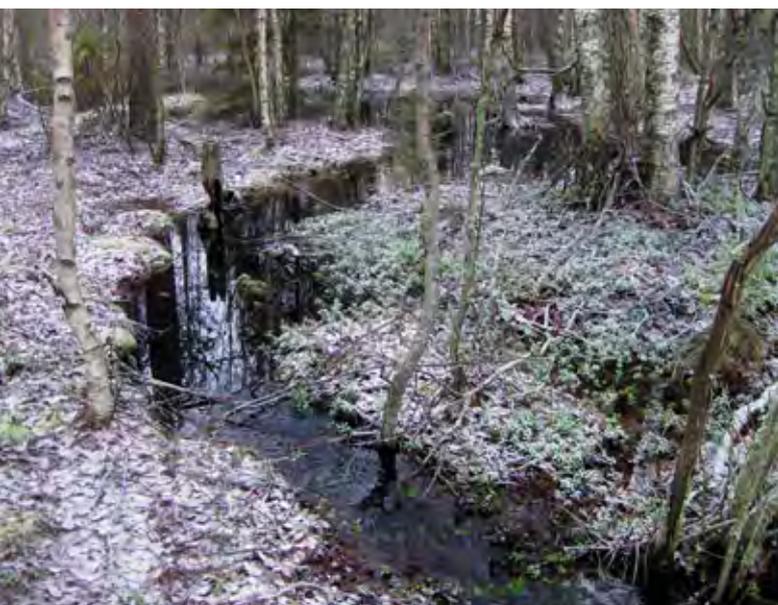
Figure 77. Water has started flowing again in the original stream from the pond. PHOTO: REIJO HOKKANEN 2009.

By spring 2010 the water level in the pond had risen about 50 cm. Water had successfully been redirected into the old stream channel (Figure 77), even though it was higher than the excavated ditch had been. The channel was full and its immediate surroundings were waterlogged to a distance of a couple of metres. Trees that had grown beside the channel were dying. Water had also encroached onto the peatland around the pond, where some trees were also dying (Figure 78).

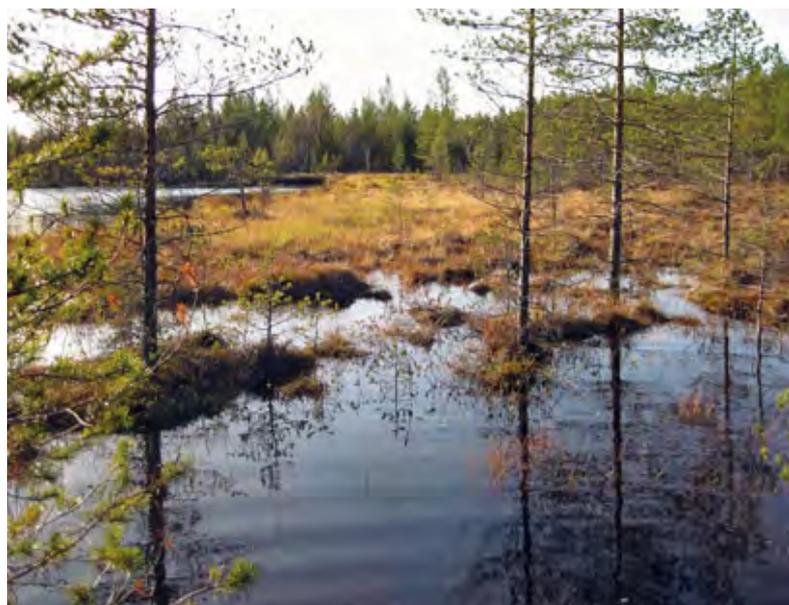
Figure 78. Water levels in the pond rose some 50 cm after restoration. Photo: REIJO HOKKANEN 2009.

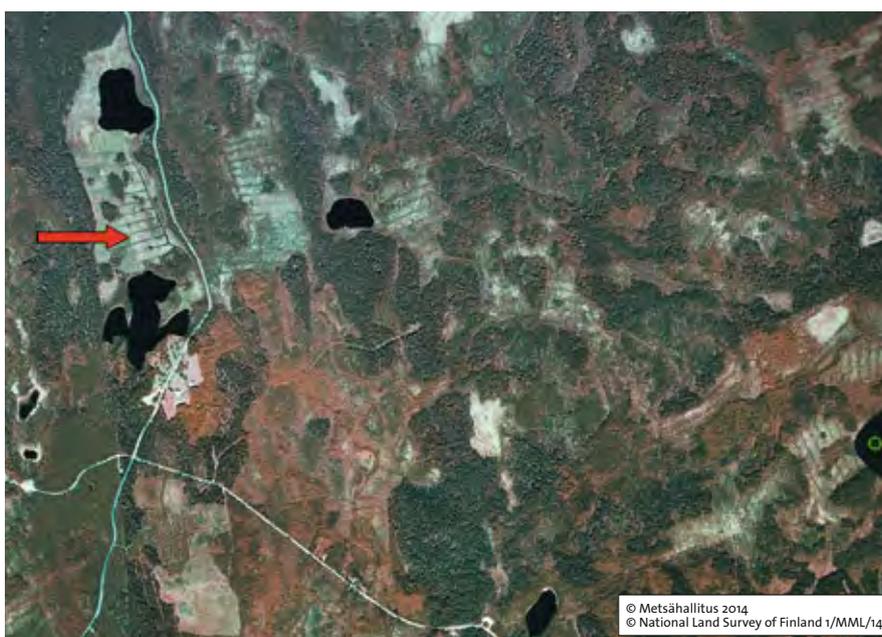
Figure 80. Aerial photograph from 1995, three years after restoration. The arrow marks Kirkaanlamminneva Fen (see main text).

photographs (Figures 79 and 80) and field observations. Two basic principles were defined for restoration, with the goal being to re-establish near natural hydrological conditions and recreate near natural landscapes.

The first ditches were infilled at Kirkkaanlamminneva Fen (Figure 80) by an excavator in autumn 1992, using peat and small-diameter trees felled alongside the ditches. No peat embankments were made.

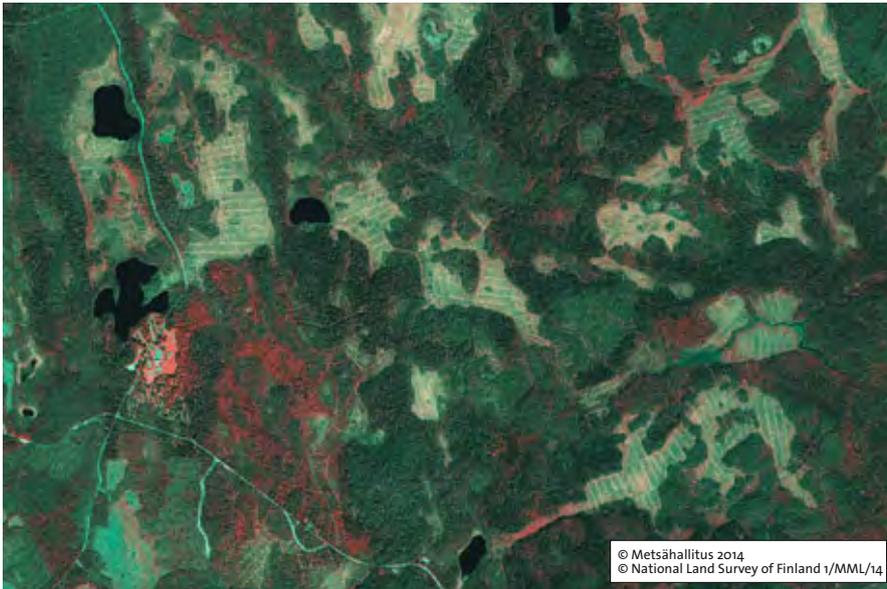
Figure 81. Aerial photograph from 2011.

The desired reversion towards a near natural state can be seen to have commenced successfully. The situation is most favourable in areas fed by significant amounts of water from higher-lying natural mires. The opportunity to restore entire catchment areas also seems to have been fruitfully realised (Figure 81).
