A Review of Marine Nature Restoration Work and Methods Used in Finland

This report contains information on various restoration methods aimed at improving the status of habitats and species in Finnish coastal waters. The report was compiled as part of the LIFE-IP Biodiversea project (2021–2029) to point the way for drawing up a national restoration plan for Finland's coastal area and, by providing examples, to support the selection of restoration measures. Although this report mainly focuses on measures used in Finland, the authors have also striven to incorporate experiences from the entire Baltic Sea and elsewhere in the world that we consider suitable for Finnish conditions. The report emphasises information aimed at facilitating the planning of future restoration measures, which is why it focuses on the lessons learned, experiences, and challenges relating to the methods, in addition to ideas aimed directly at improving or developing them. The report also sums up the costs incurred from various measures to support planning processes.

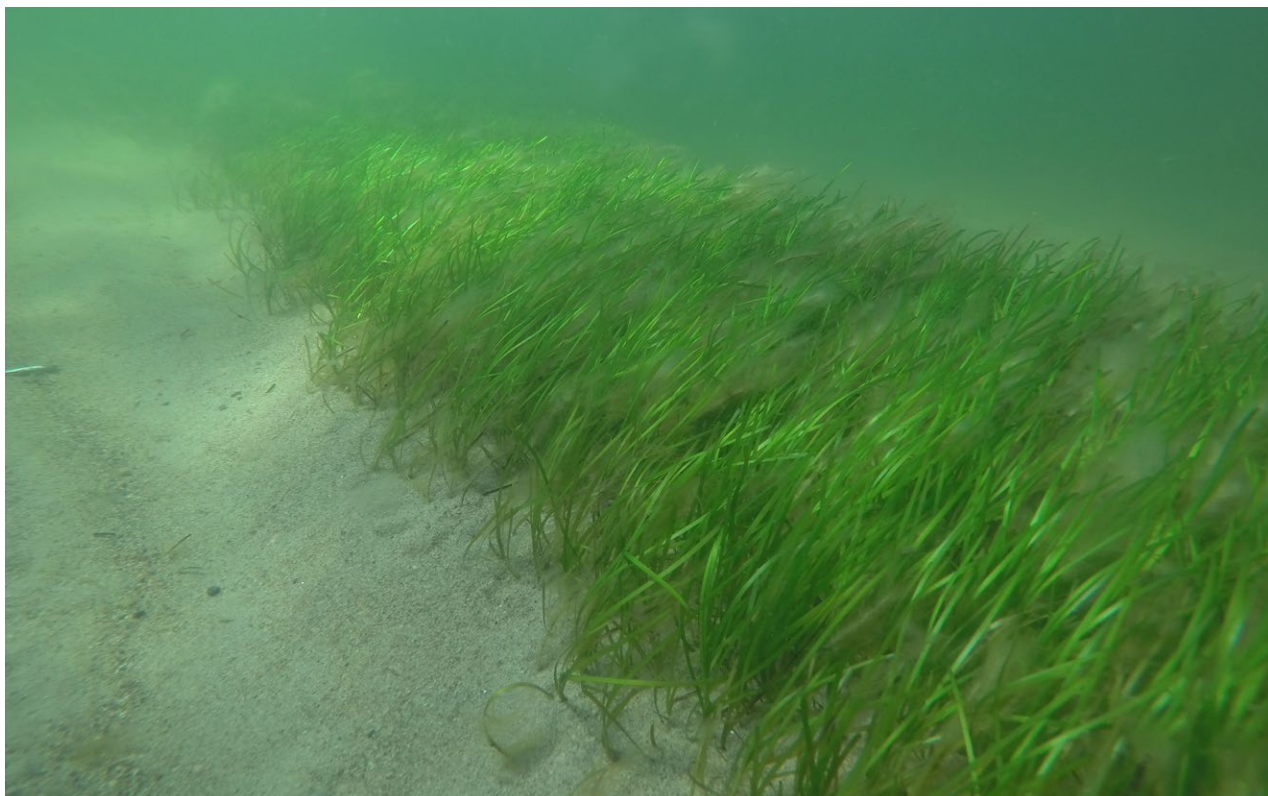
Figure 1. A dense eelgrass meadow south of Hankoniemi. Photo: Aija Nieminen/Metsähallitus.

Eelgrass is known globally as a keystone species that provides shelter and food for many other organisms. In northern parts of the Baltic Sea, eelgrass meadows form important three-dimensional habitats and biodiversity hotspots on otherwise barren sandy bottoms, and an abundance of algae, invertebrates and juvenile fish live in the shelter of the colony (Figure 1).

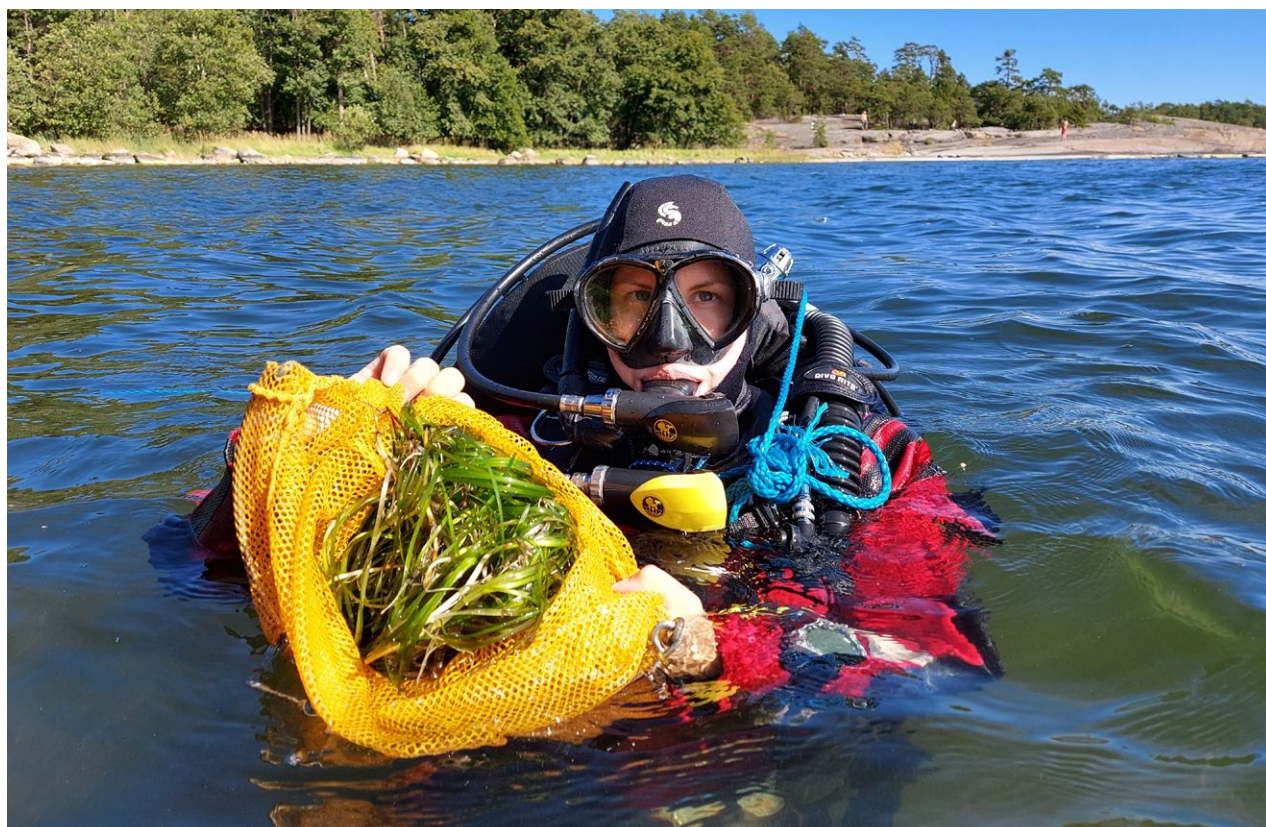
Figure 3. While the work is in progress, eelgrass shoots can be conveniently kept in a net bag, from which the diver can grab a suitable bunch for planting. Photo: Joonas Hoikkala/Metsähallitus.

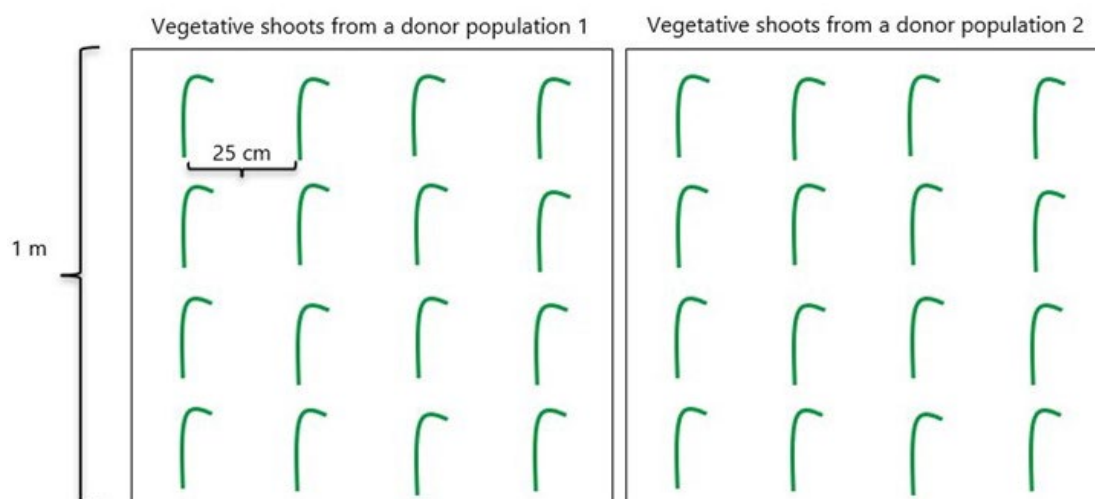
Figure 5. Example of Metsähallitus' planting technique in 2020. Planting tests were carried out following the recommendations of the Swedish handbook by Moksnes et al. (2016). Sixteen vegetative shoots were planted in an area of one square metre with 25 cm spacing, using shoots from two different donor populations. Figure: Aija Nieminen/Metsähallitus.

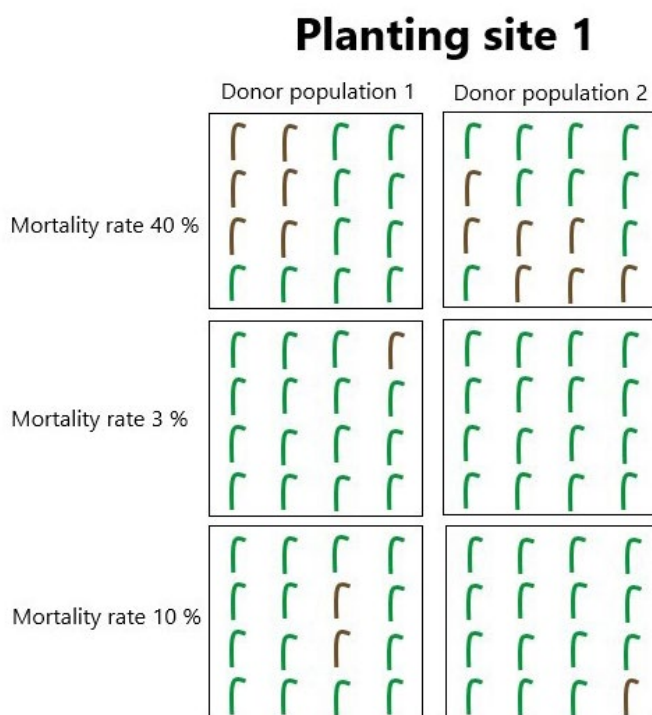
Figure 6. Example of shoot mortality at Metsähallitus' test site 1, planted in 2020. Surviving shoots are shown in green, with dead or lost shoots in brown. The shoot mortality rate was the highest in the shallowest planting areas, whereas, in deeper areas, it was 3% to 10% at both sites 1 and 2. Figure: Aija Nieminen/Metsähallitus.

At both sites, the plants have been least successful at the shallowest sites, and they were covered with filamentous algae on most monitoring visits. The shallowest transplantation sites also had the highest rate of post-planting shoot mortality (Figure 6). The shoot mortality rate in the shallowest area was 40% at site 1 and 50% at site 2, and almost equal

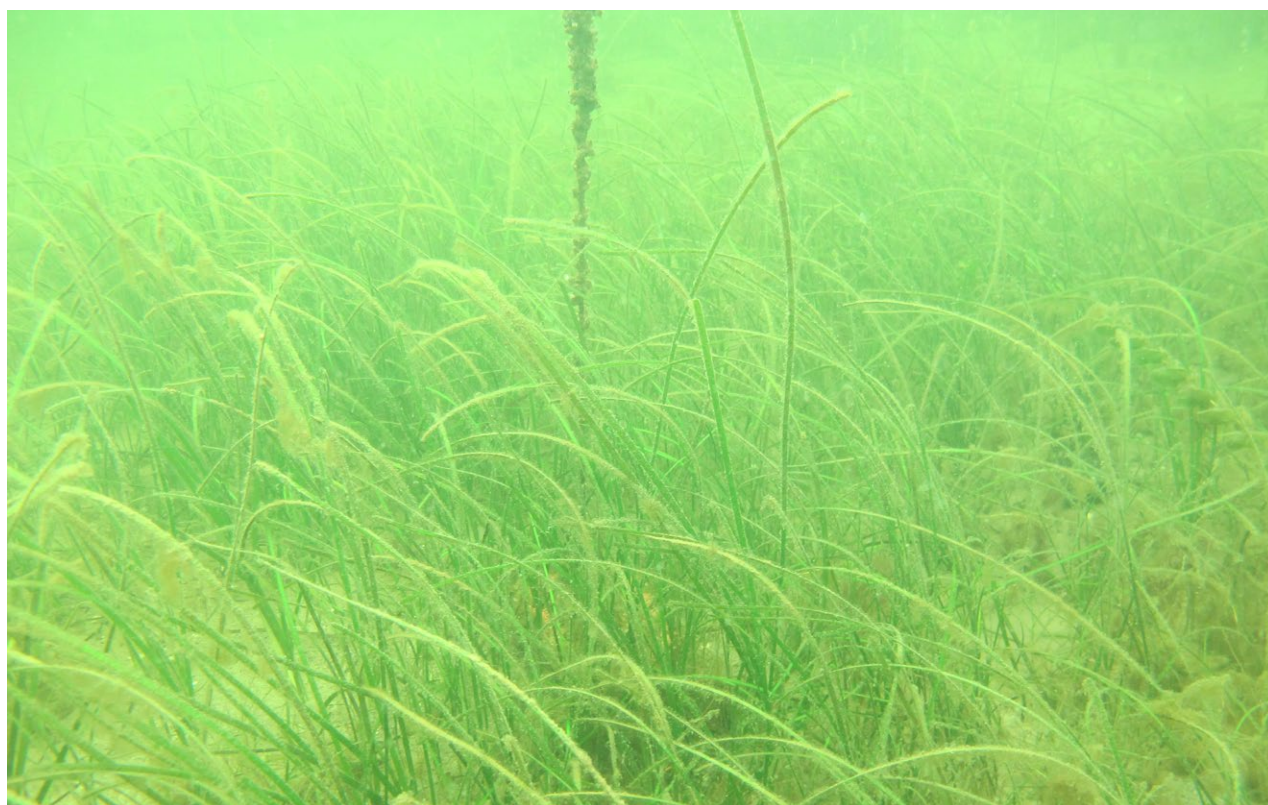
Figure 7. A photo of eelgrass transplanted in August 2020 in late summer 2022. The brick attached to the bottom with a steel bar can barely be seen among the plants. The transplanted eelgrass has started growing well and likely merged with the natural eelgrass meadow at the site. Photo: Joonas Hoikkala/Metsähallitus.

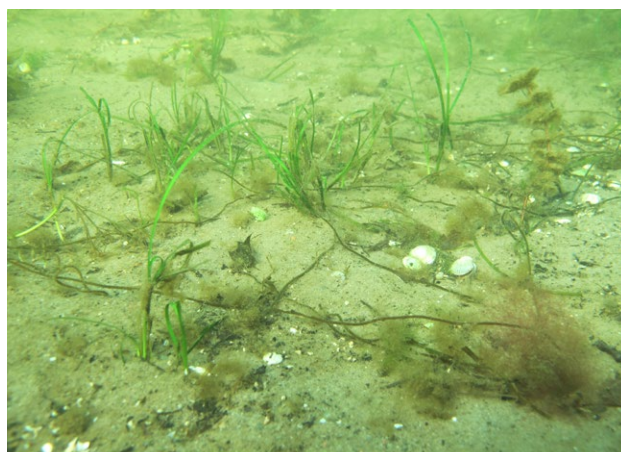
Figure 8. Common eelgrass transplantation site in June 2022 (left) and August 2022 (right). While the plants had started to grow well, as expected in June 2022, they may have been affected by a heatwave during the summer. Unfortunately, there was no automated temperature logger at this site that could have verified the temperature increase. Photos: Joonas Hoikkala/Metsähallitus.

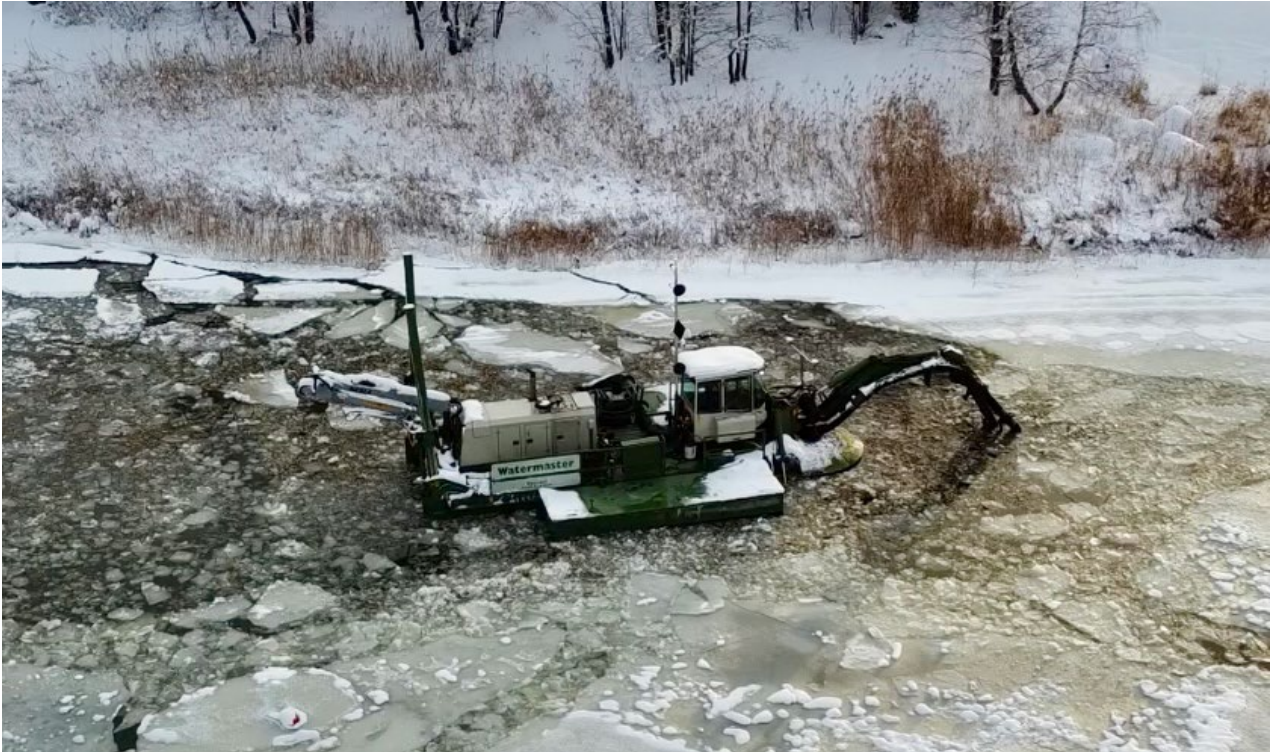
Figure 10. Suction dredging of the sediment in the straits of the Pappilansaari Islands, Hamina. Photo: Harri Huuho/MeriHamina Association.

Suction dredging was also used at this site. The dredged sludge and bottom material were run through a pipe into a special bag-like textile container called a geotube placed on dry land (Figure 11). In the geotube, water-containing sludge gradually settles due to gravity, while a polymer added to the sludge causes water to filter through the geotube's fabric. After this, the sludge can be used for

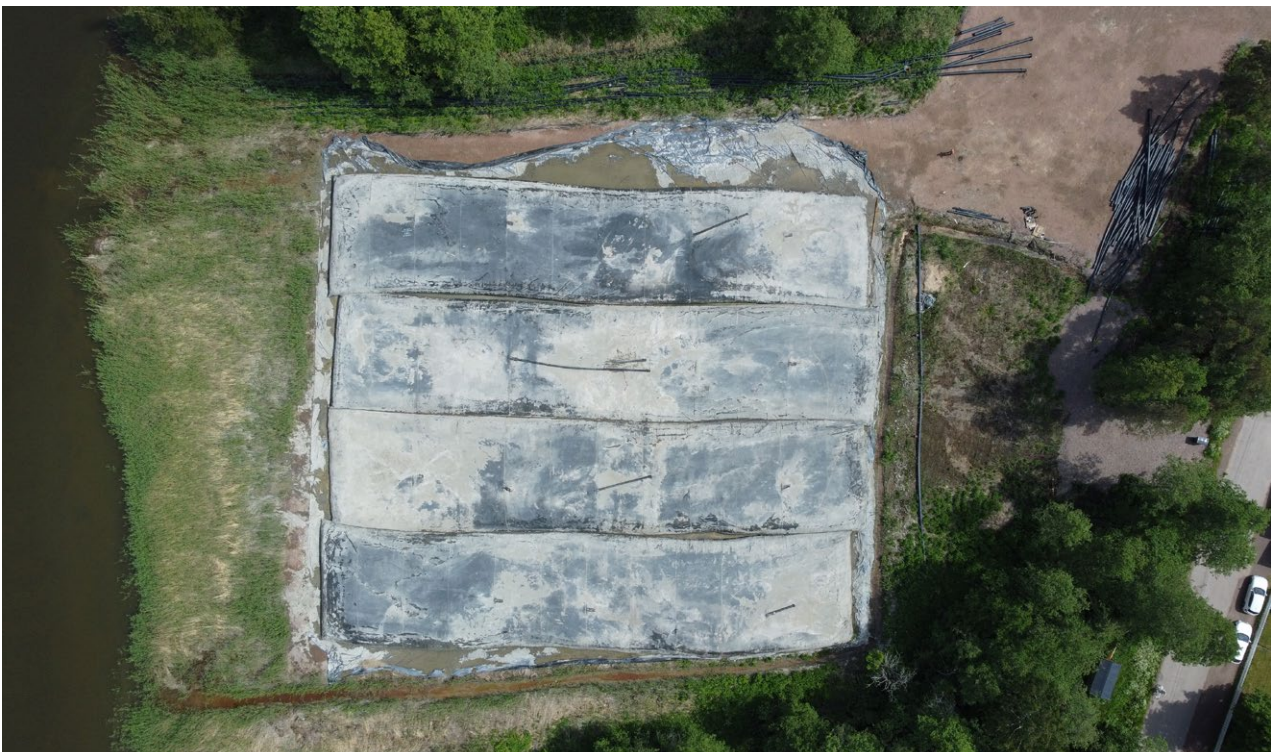
Figure 11. Aerial photograph of a geotube field. Photo: Harri Huuho/MeriHamina Association.

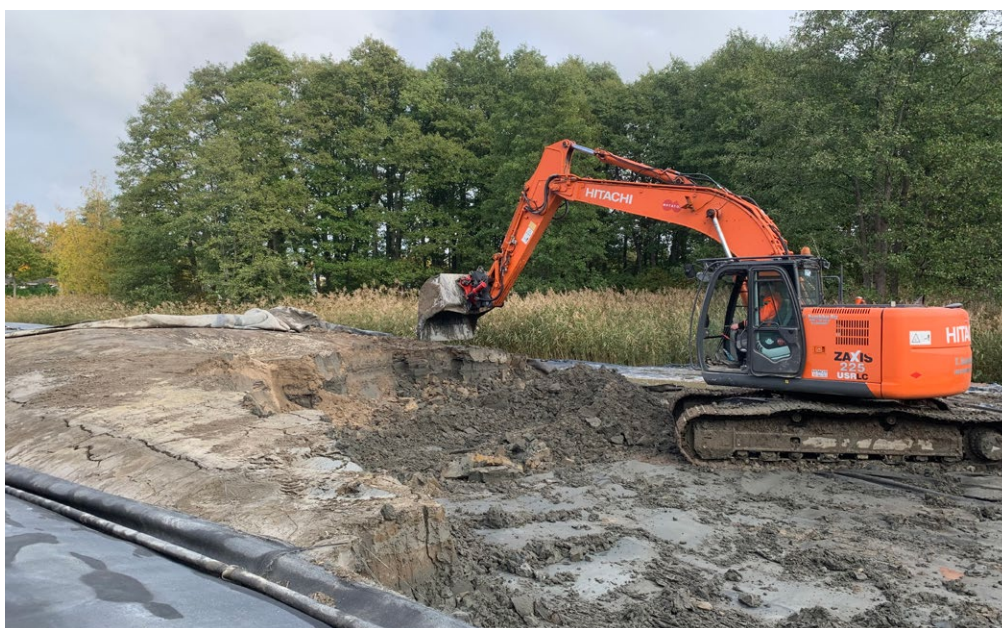
Figure 12. Dredged spoil that has solidified within a geotube. Depending on its properties, the spoil can be used in landscaping and for other similar purposes. Photo: Harri Huuho/MeriHamina Association.

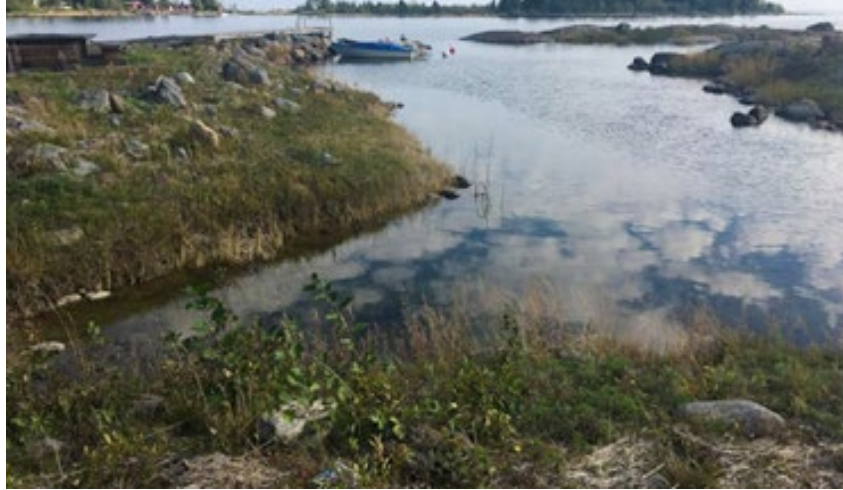
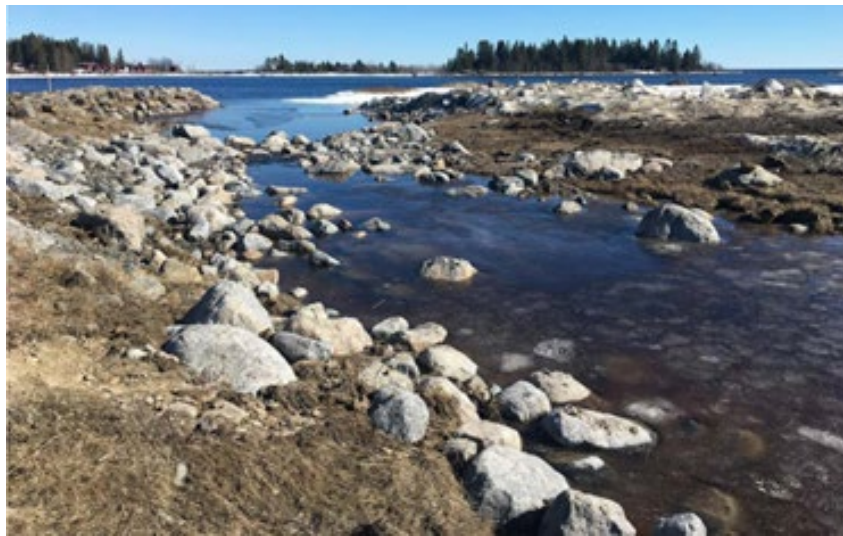
Figures 13 and 14. Photos of the sill in Halskärsgraven before and after restoration. Photo: Anniina Saarinen/Länsstyrelsen Västerbotten.

The goal of the measure was to close two man-made channels and to restore the natural inlet and sill. An excavator was used to carry out the work. While stone material was returned to the sill in the two previous examples, in Långviken, finer-grained materials

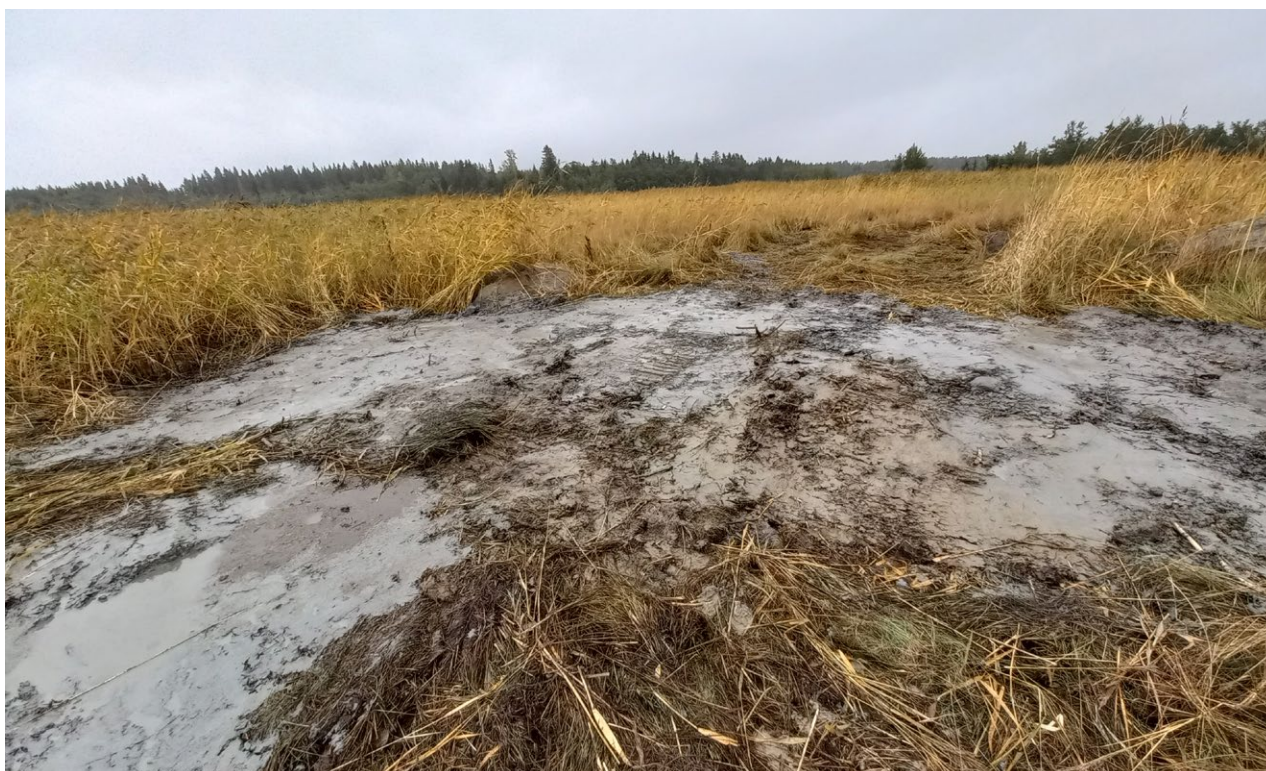
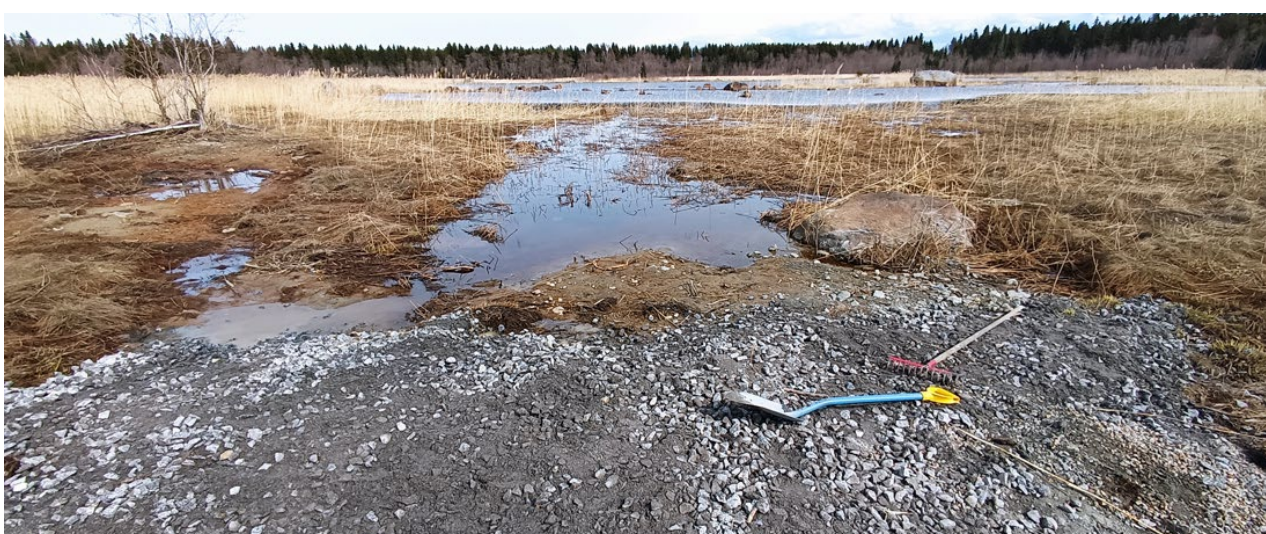
Figures 15 and 16. In Långviken, the goal of the restoration was to close two man-made channels and to restore the natural inlet and sill. Aggregate, clay and gravel for the work were found in situ and also obtained off-site. Photos: Ralf Wistbacka.

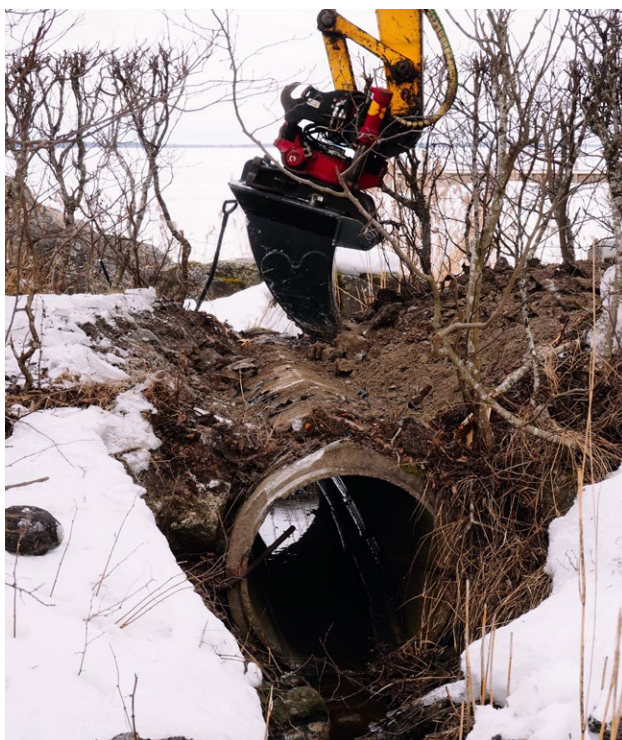
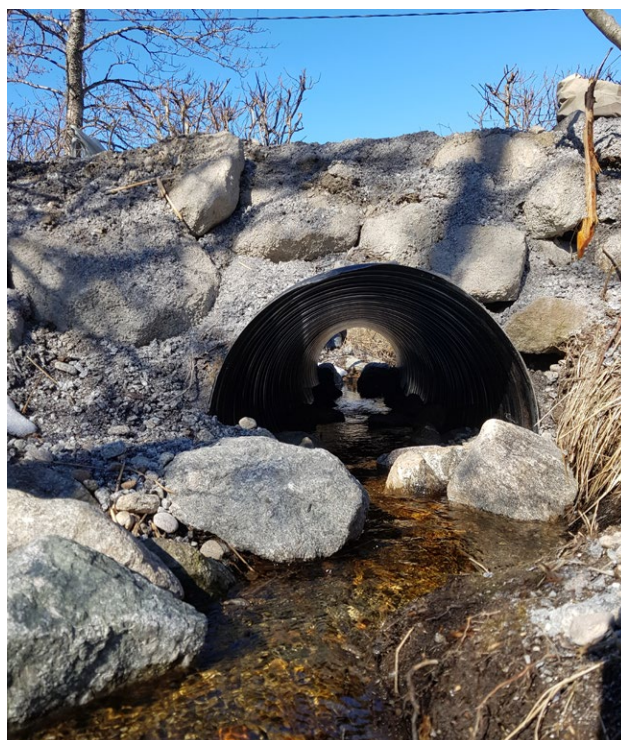
Figures 17 and 18. Verkvikfladan culvert before and after restoration: Photo taken before restoration: Maija Haukkala/Metsähallitus 2019, after restoration: Anette Bäck/Metsähallitus 2021.

stream bisected by a road embankment, under which was a culvert of concrete rings. The culvert was built in the 1990s and placed directly on the bottom of the stream. A crack had later appeared between the two concrete rings, after which the water primarily flowed under them. This reduced the flow inside the rings to a level that was too low for migrating pike, perch and roach for most of the spring. The stream was relatively small, approximately 30 to 40 cm wide and 20 cm deep. A decision was made to replace the old culvert with a new round culvert of the same diameter (80 cm) to minimise changes to the channel. The site was restored in 2019, and the new culvert was installed at a depth of 30 cm into the ground and stabilised to prevent seawater from moving it (Figures 17 and 18). The new culvert was filled with natural gravel and boulders to make the channel as natural as possible. Stones were also added to the channel above and below the culvert to ensure a suitable gradient and the availability of resting and 'staging' areas for fish.

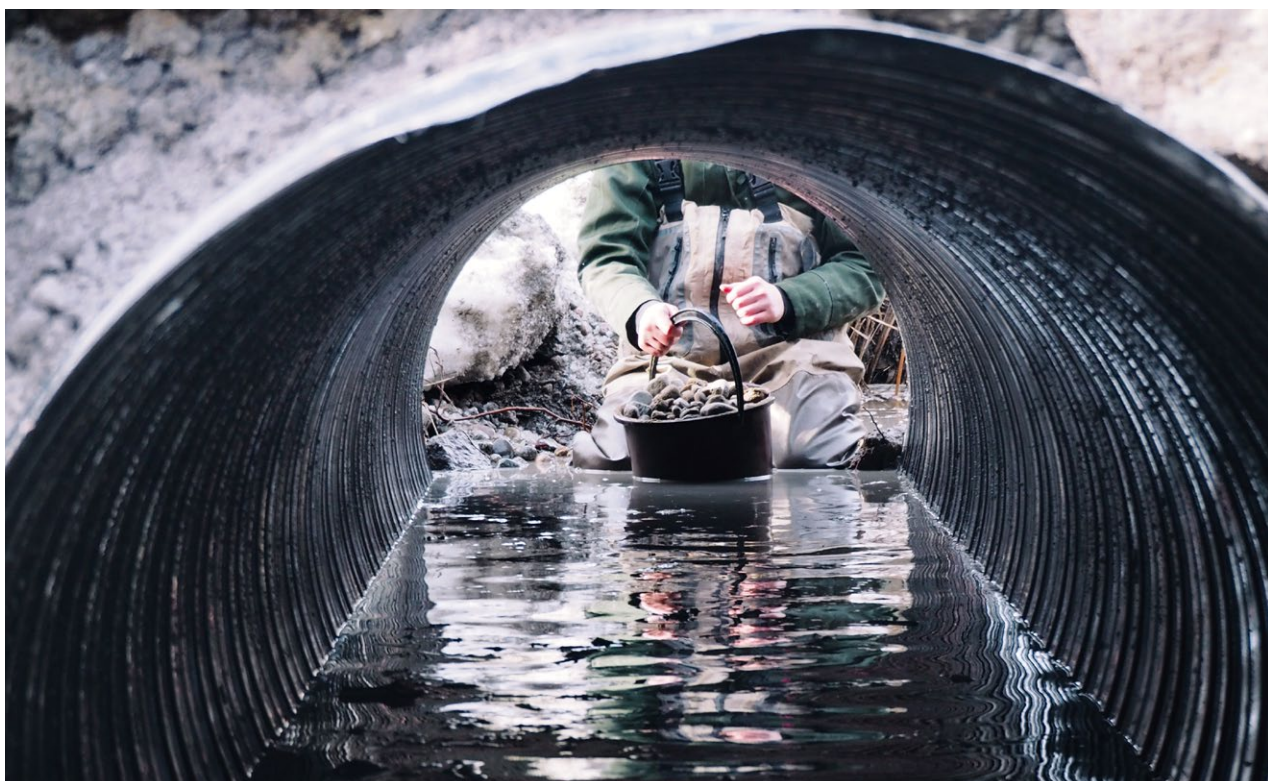
Figure 19. The culvert was installed deeper into the ground and filled with gravel and stones to create a channel extension that was as natural as possible. Photo of Verkvikfladan: Maija Haukkala/Metsähallitus 2019.

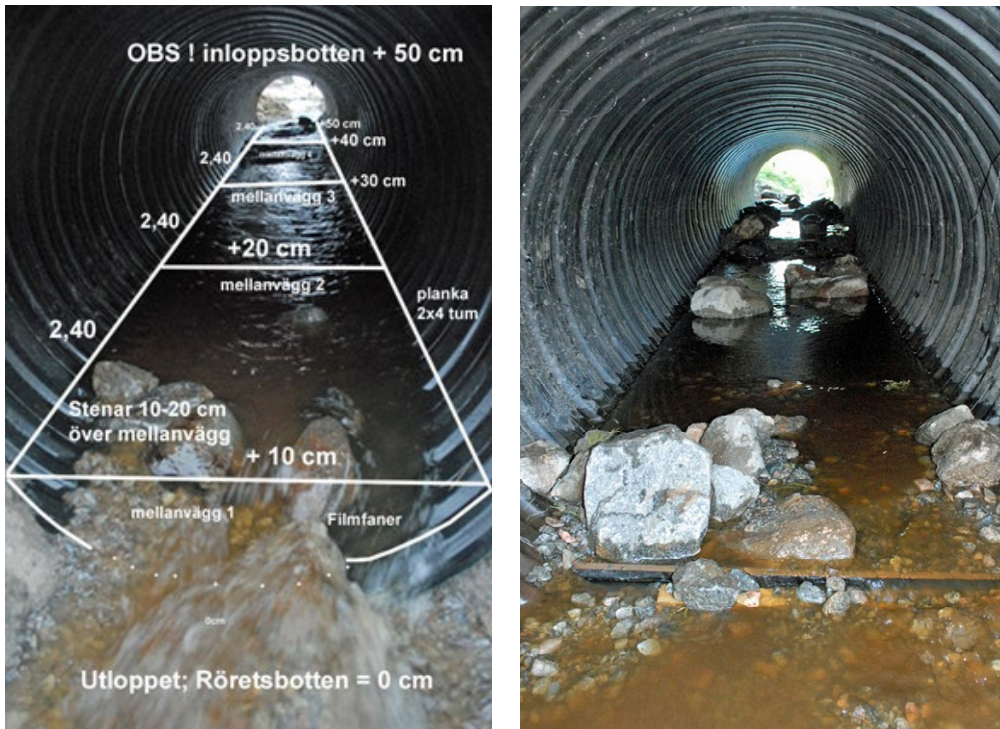
Figures 20 and 21. The channel to be restored had a steep slope, so a decision was made to build a fish pass inside the culvert and fill it with gravel and rocks, creating a natural, gradual slope where spawning fish can rest and pick up speed. The water level is still relatively low in this photo. Photos: Ralf Wistbacka 2013.

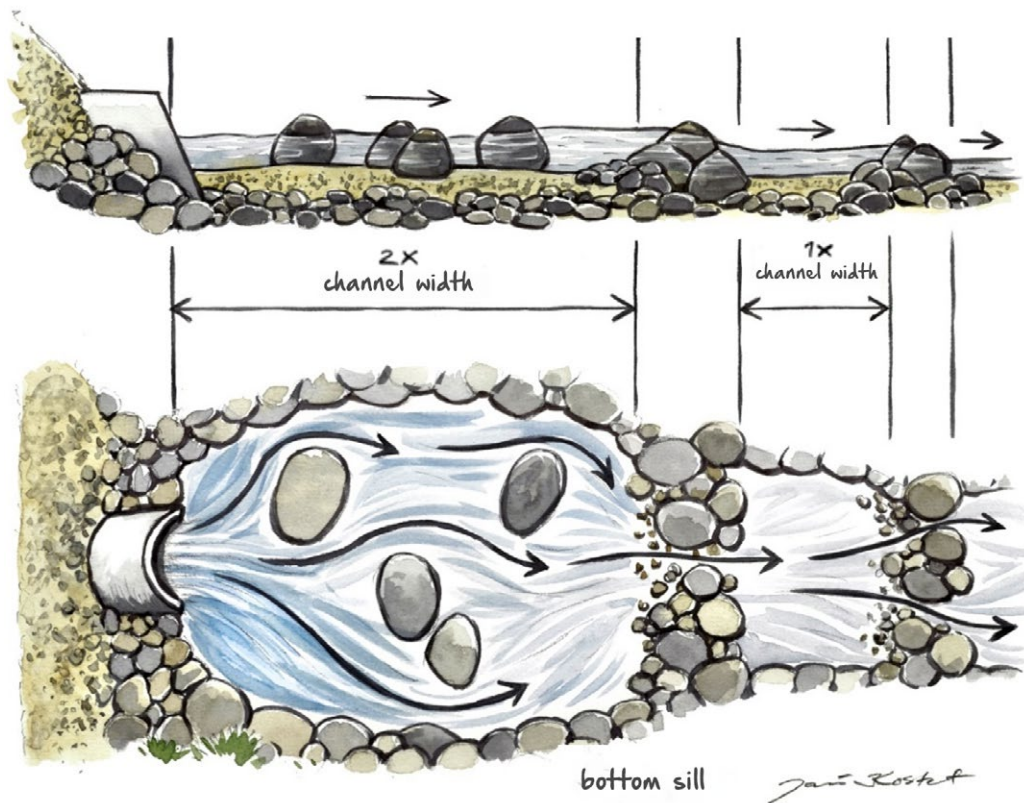
Figure 22. An inaccessible culvert can be restored by building sills with stones and timber in the channel below the culvert. The purpose of the sill is to raise the water level in the culvert and to enable the passage of aquatic organisms through it. Adding stones can also eliminate a fall below the culvert to the channel bottom and/or the water surface. Photo: Jari Kostet/Metsähallitus 2020.

The most common and easiest way to restore an inaccessible culvert is to raise its water level by building a sill in the stream channel below it (Karppinen 2020, Figure 22). This increases the water depth and moderates the slope while also reducing the flow rate in the structure. Stones can be used to eliminate

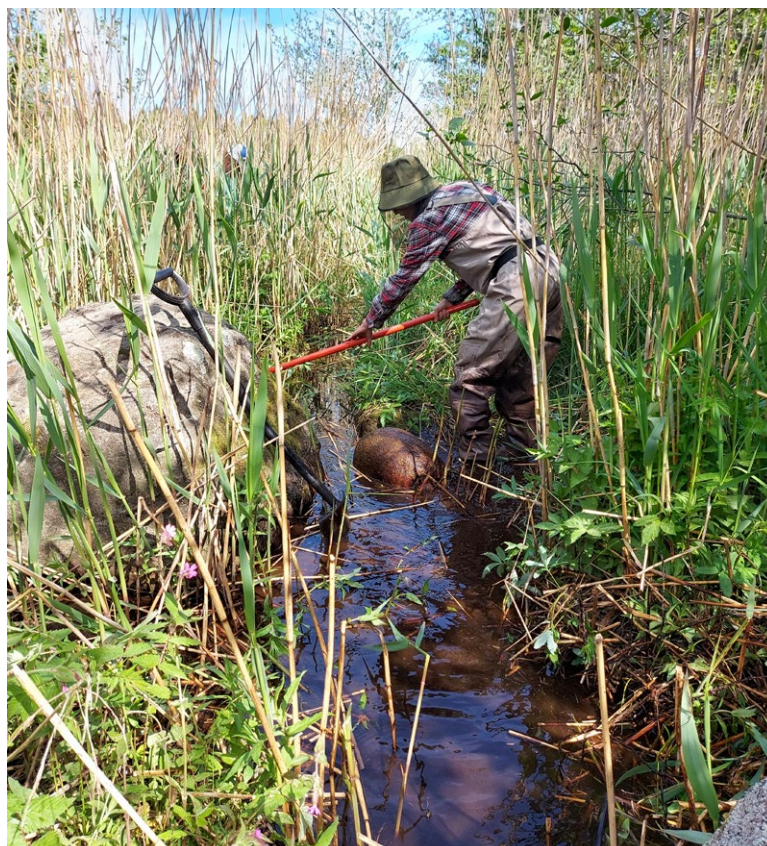
Figure 23. The channel in Dollosverkan was cleared with a scythe and hoe fork. Photo: Anette Bäck/Metsähallitus 2021.

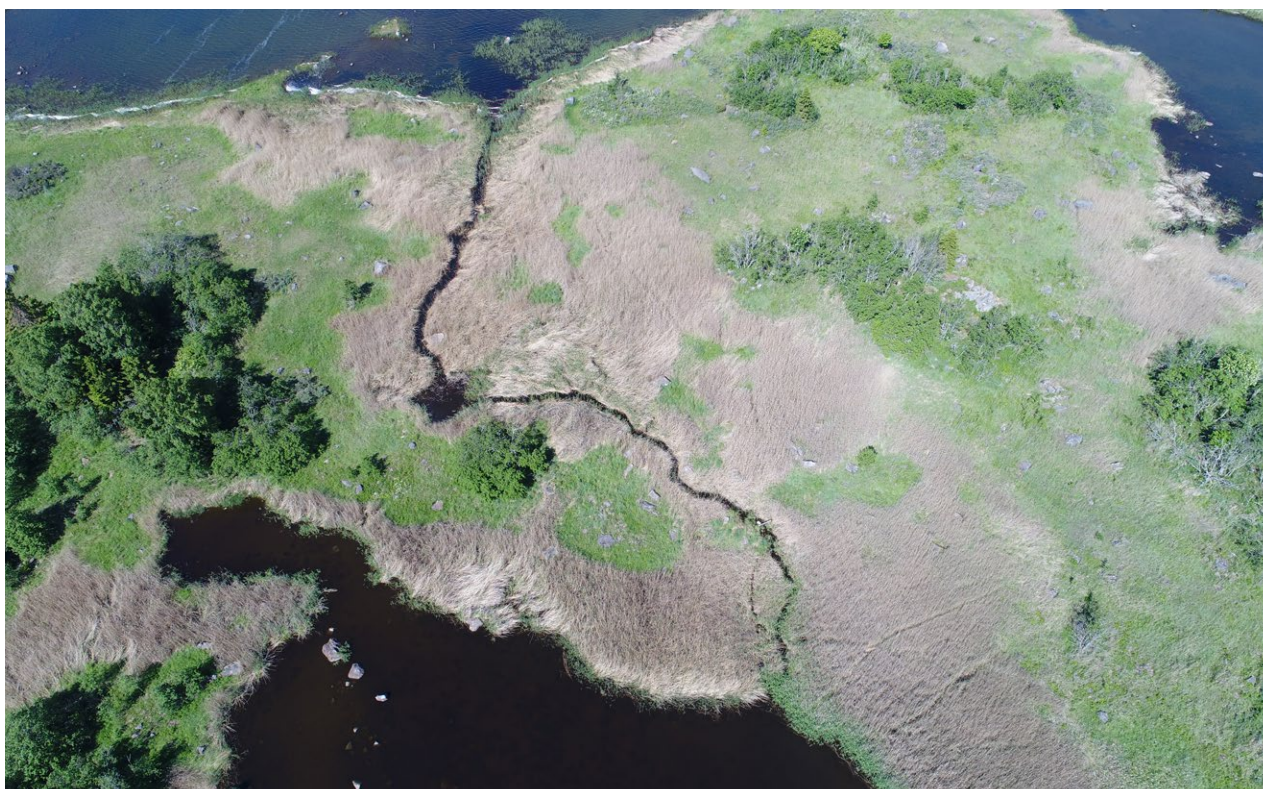
Figure 24. Restored channel of Roliggropen in an aerial photograph. Photo: Anette Bäck/Metsähallitus 2022.

Roliggropen and Dollosverkan are example sites where the vegetation was removed using manual tools, whereas in Norrfjärden, parts of the channel bottom were also covered with stones to reduce the reed bed's capacity to regenerate.

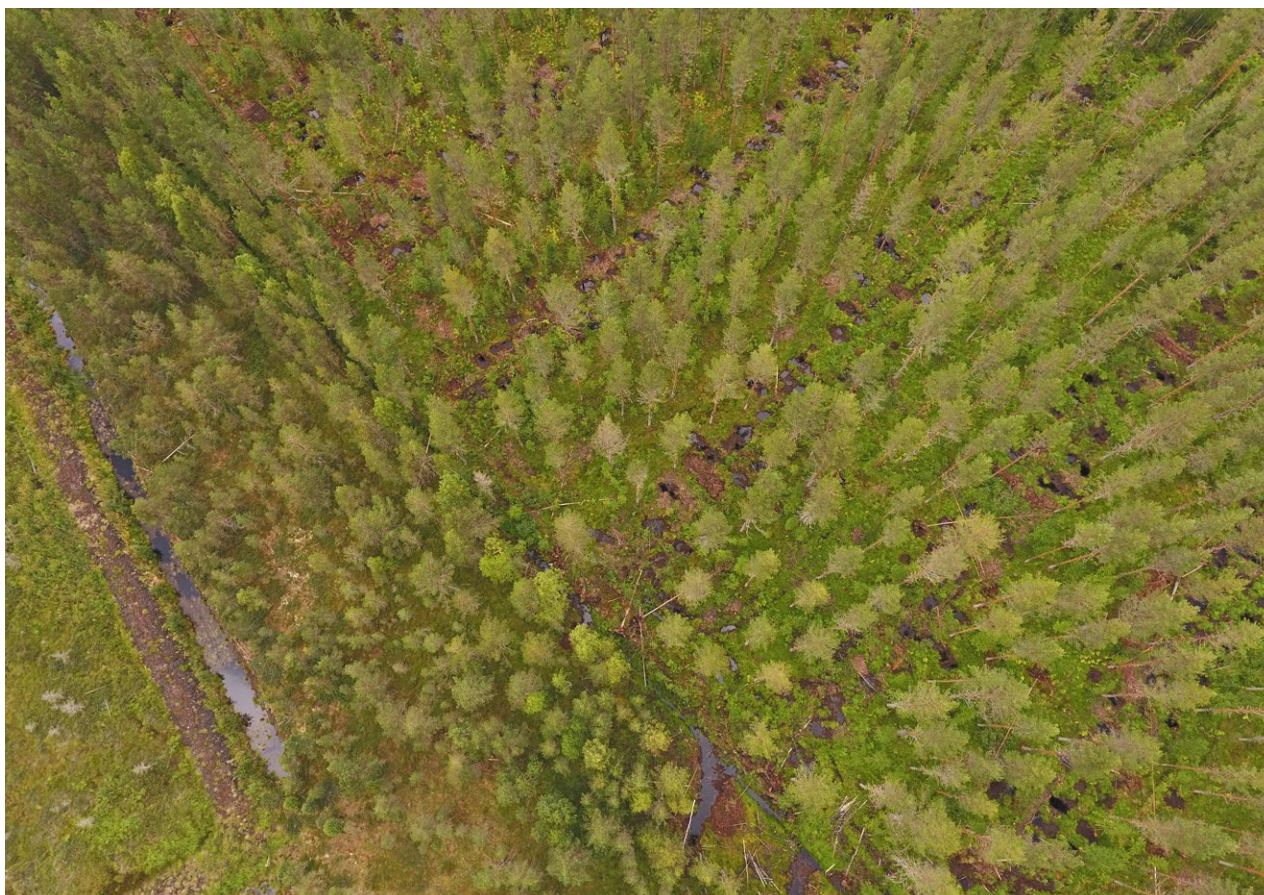
Figure 25. Blocked ditches, Pohtiinsuo. Photo: Maarit Similä 2018.

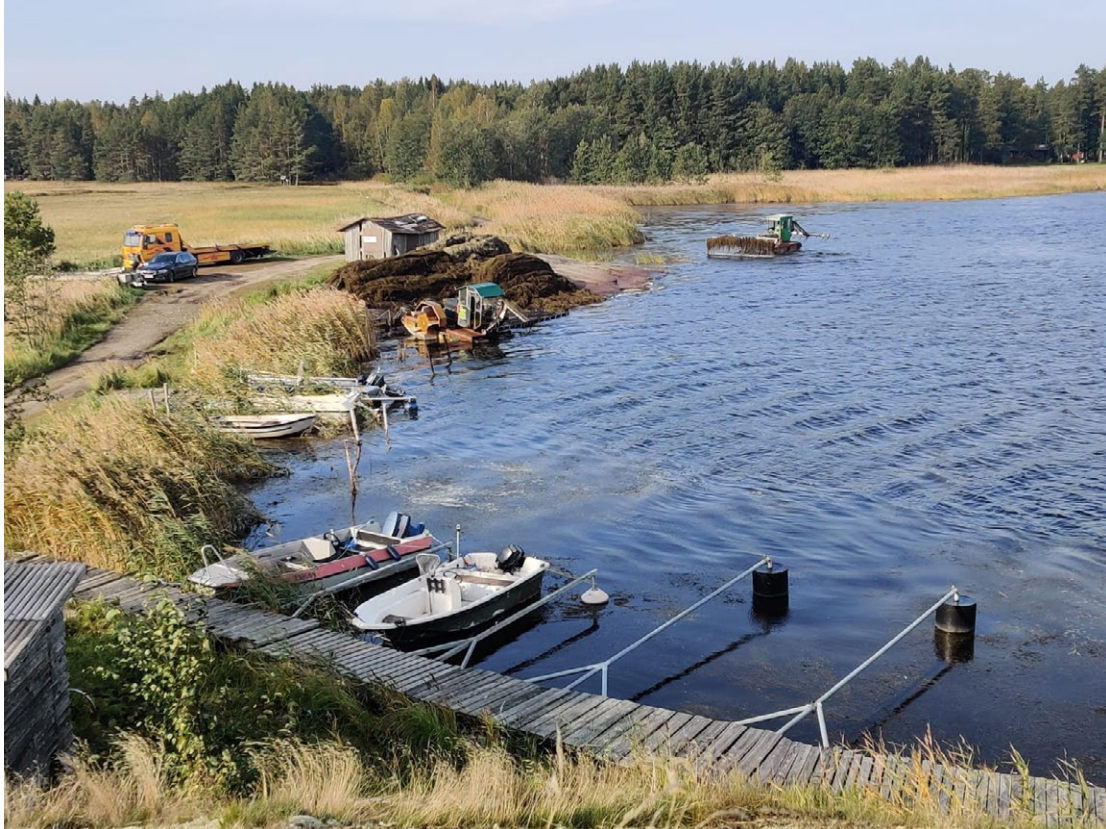
Figure 27. Mowers removing *Myriophyllum spicatum* in Täktominlahti Bay in August 2020. The collected plant mass was allowed to dry on the shore for about a week before being transported to a nearby field. Photo: Asmo Paloniitty.

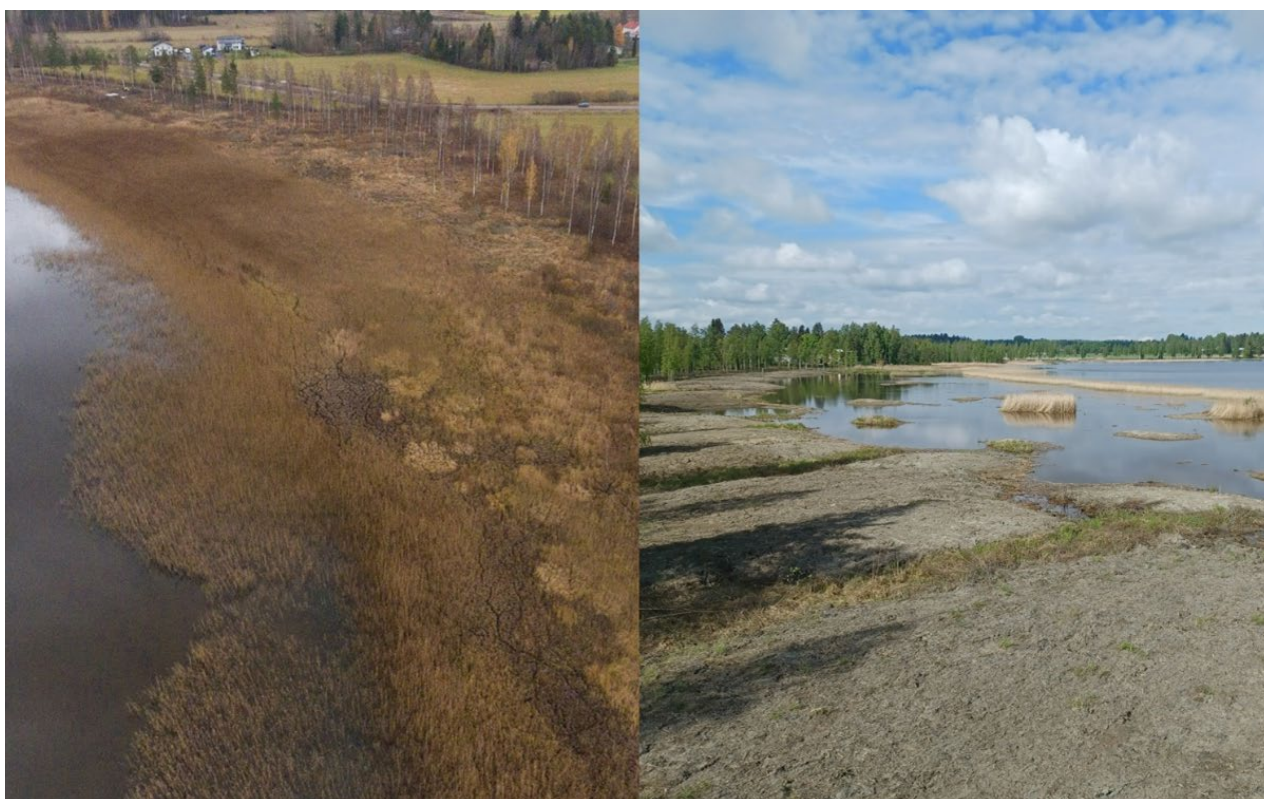
Figure 28. Nisoksenlahti Bay before and after reed removal. Photos: Ville Rähä/ELY and Laura Tulokas/Vemarak Oy.

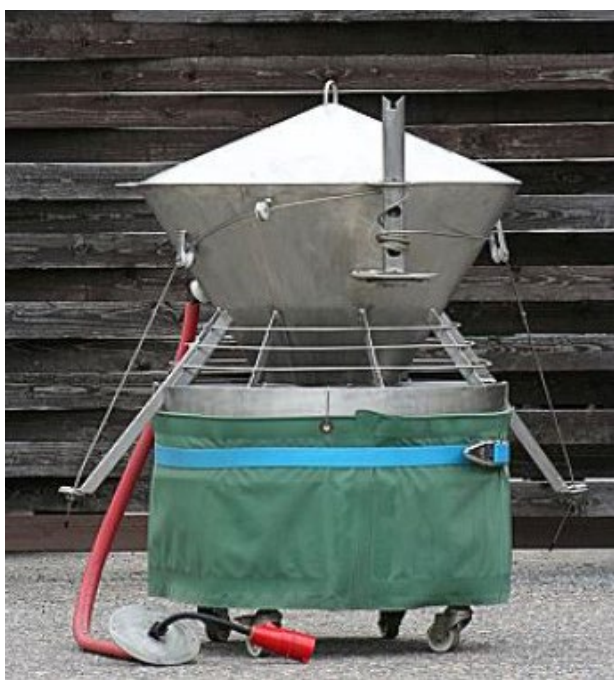
Figure 30. Mixox MC 1100 oxygenation device (diameter 110 cm). Photo: Saarijärvi et al. 2012.

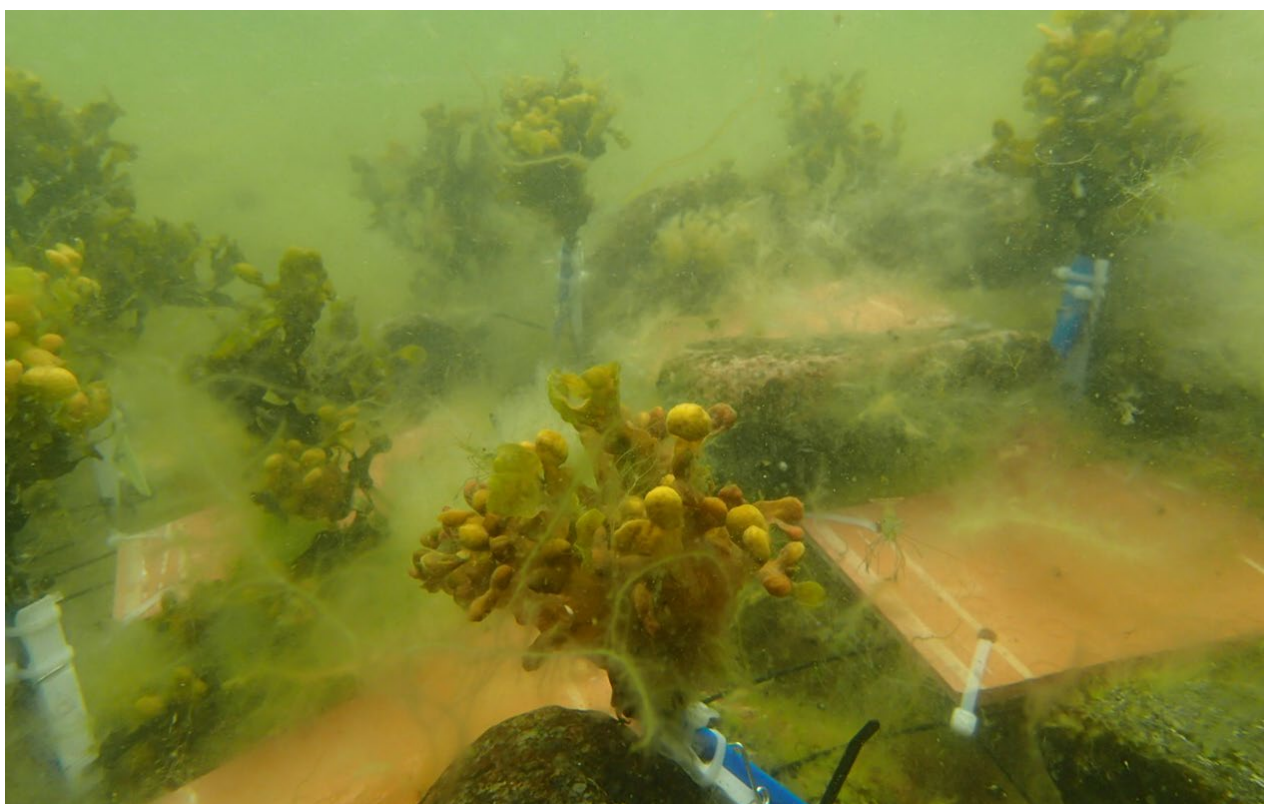
Figure 31. Experiment design for bladderwrack reproduction in the Archipelago Sea in 2020. Photo: Tiina Salo.

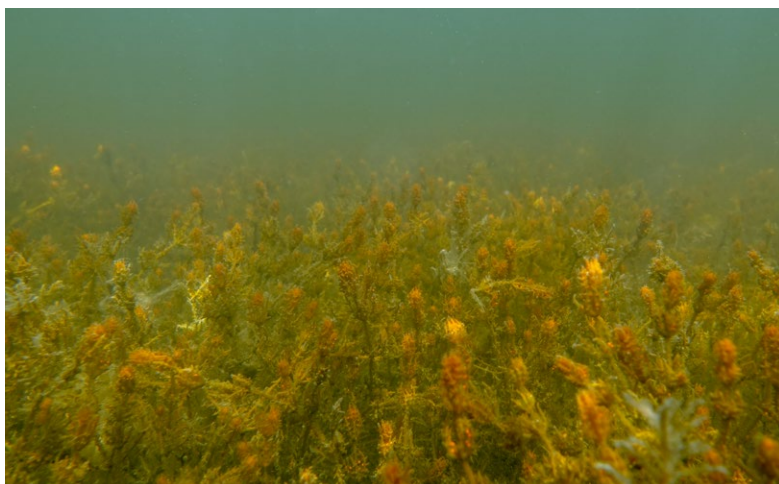
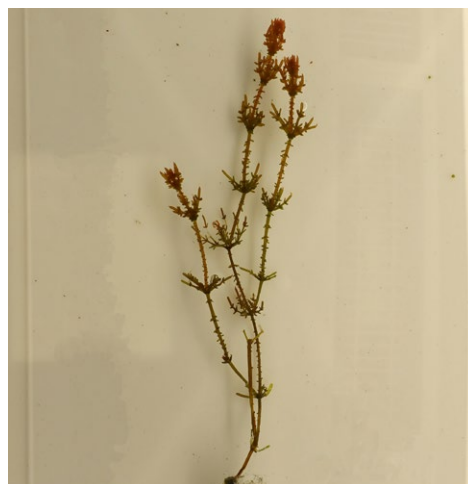
Figures 32a and 32b. Charophyte meadow in a sheltered bay. *Chara tomentosa* in a water container. Photos: Roxana Preston and Henna Raitanen.

Stoneworts have relatively simple thalli, compared to vascular plants, which have specialised tissues formed by differentiated cells. The stonewort thallus grows from the bottom sediment towards the water surface and has whorls of branchlets that somewhat resemble leaves (Figure 32b). The stonewort's reproductive structures (oogonia and antheridia) appear on these branchlets, while its rhizoids grow in the sediment. Certain stonewort species have starch-filled bulbils in their rhizoids. It is species dependent to what degree these abovementioned structures are used for
