A Review of Marine Nature Restoration Work and Methods Used in Finland

This report contains information on various restoration methods aimed at improving the status of habitats and species in Finnish coastal waters. The report was compiled as part of the LIFE-IP Biodiversea project (2021–2029) to point the way for drawing up a national restoration plan for Finland's coastal area and, by providing examples, to support the selection of restoration measures. Although this report mainly focuses on measures used in Finland, the authors have also striven to incorporate experiences from the entire Baltic Sea and elsewhere in the world that we consider suitable for Finnish conditions. The report emphasises information aimed at facilitating the planning of future restoration measures, which is why it focuses on the lessons learned, experiences, and challenges relating to the methods, in addition to ideas aimed directly at improving or developing them. The report also sums up the costs incurred from various measures to support planning processes.

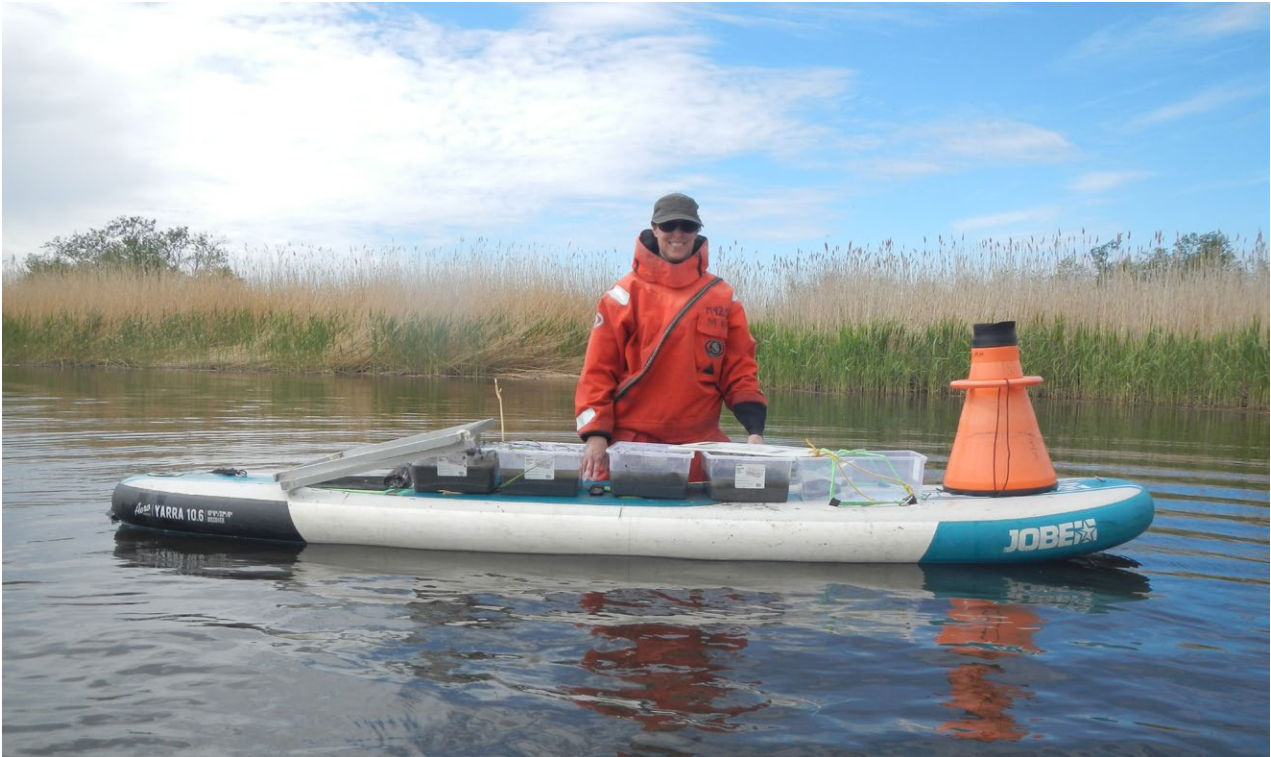
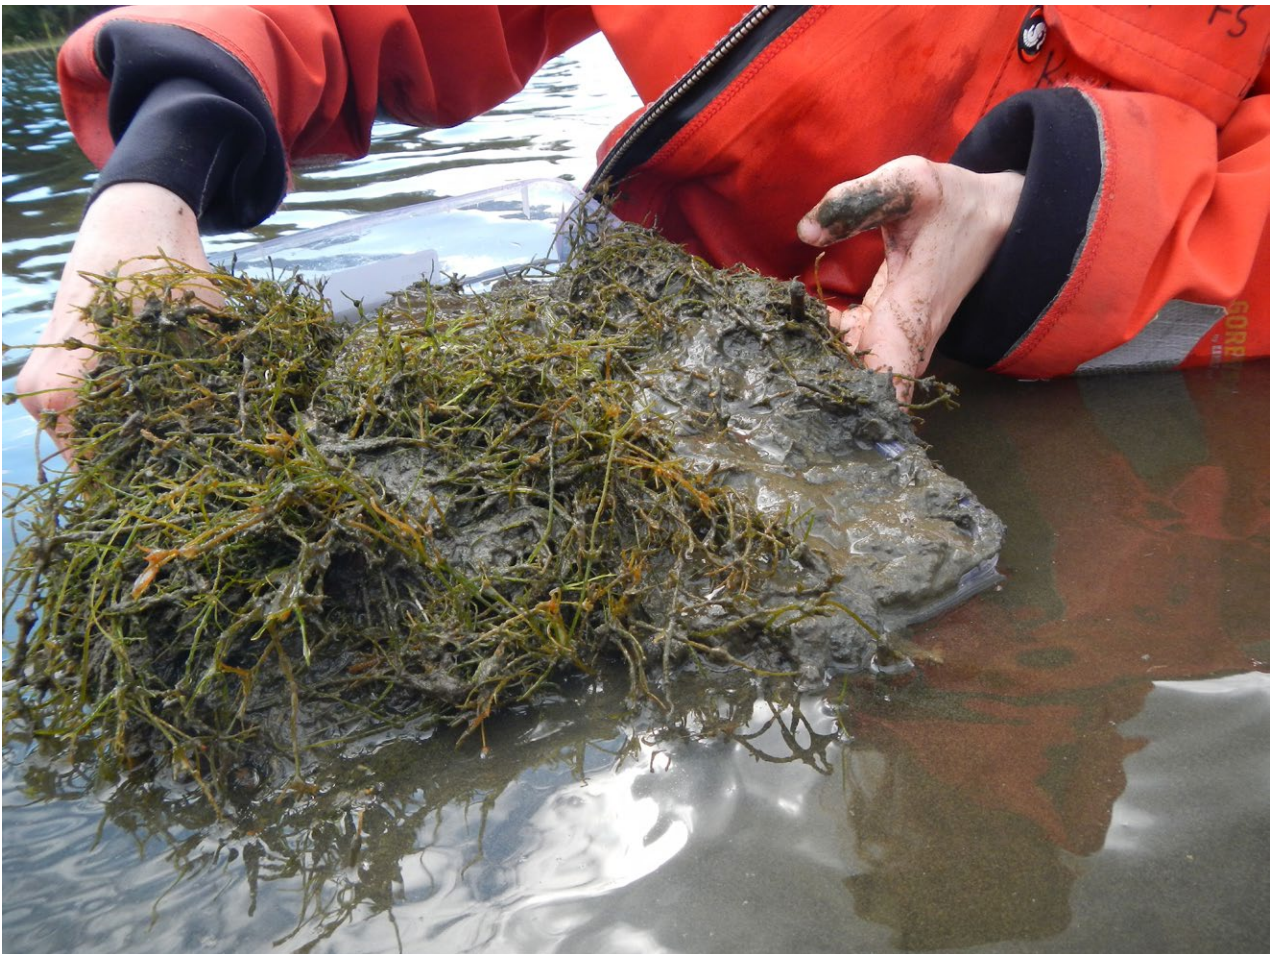
Figures 33a and 33b. Metsähallitus transplanted the stoneworts manually. The team were equipped with SUP boards, aquascopes, boxes for collecting charophytes, metal frames, and a GPS device to mark the planting site. Photos: Anette Bäck (upper), Essi Keskinen (lower), Metsähallitus.

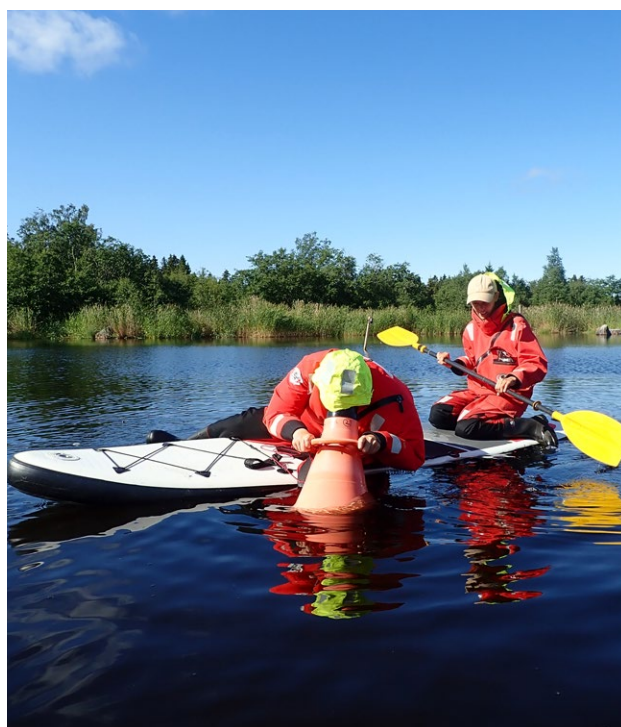
Figures 34a and 34b. Monitoring. Photos: Essi Keskinen / Metsähallitus.

Surveys were conducted to monitor Metsähallitus' transplantation sites in 2022 and 2023 using SUP boards and aquascopes based on GPS coordinates recorded while planting. The sediment is very soft in this area, and the visibility is extremely poor (Figure 34). This made finding the stoneworts difficult while the monitoring was in progress. The metal frames were found to have sunk into the sediment.

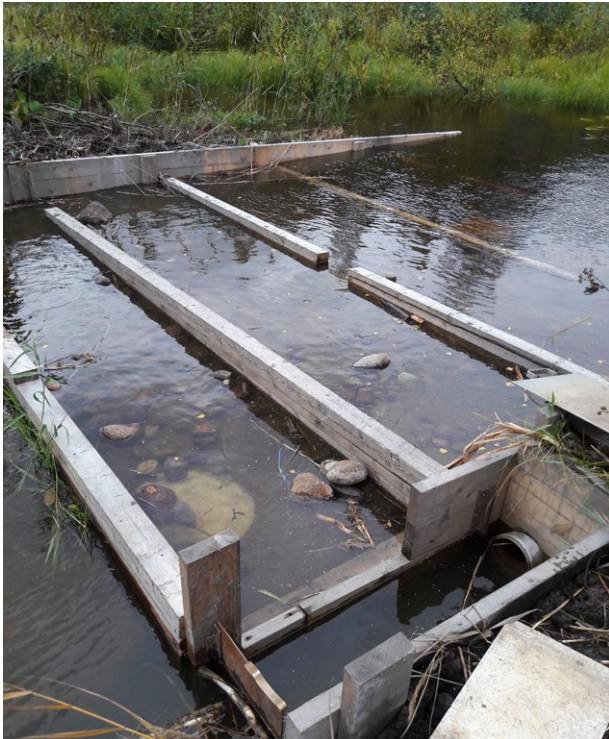
Figure 36. A fishway leading to a gloe lake helps fish migrate to their spawning grounds in the spring. Photo: Sanna Kuningas/Natural Resources Institute Finland.

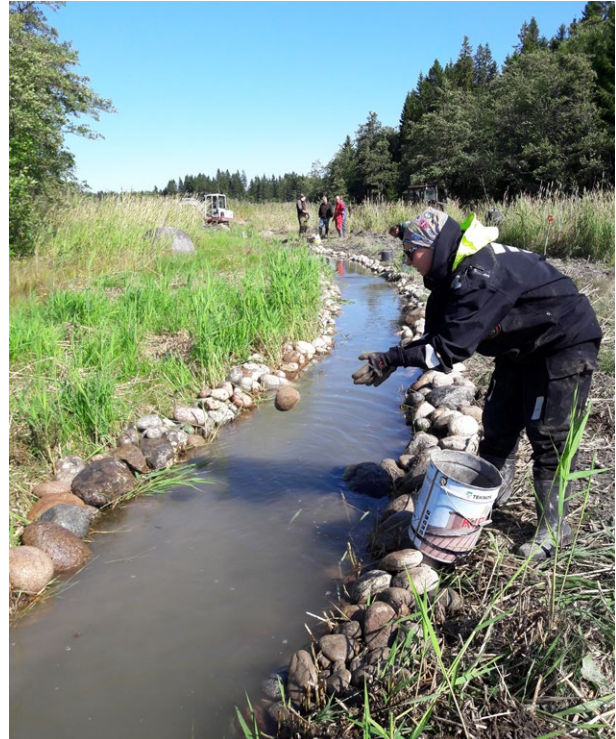
Figure 37. Plenty of stones are placed in the channel. Photo: Sanna Kuningas/Natural Resources Institute Finland.

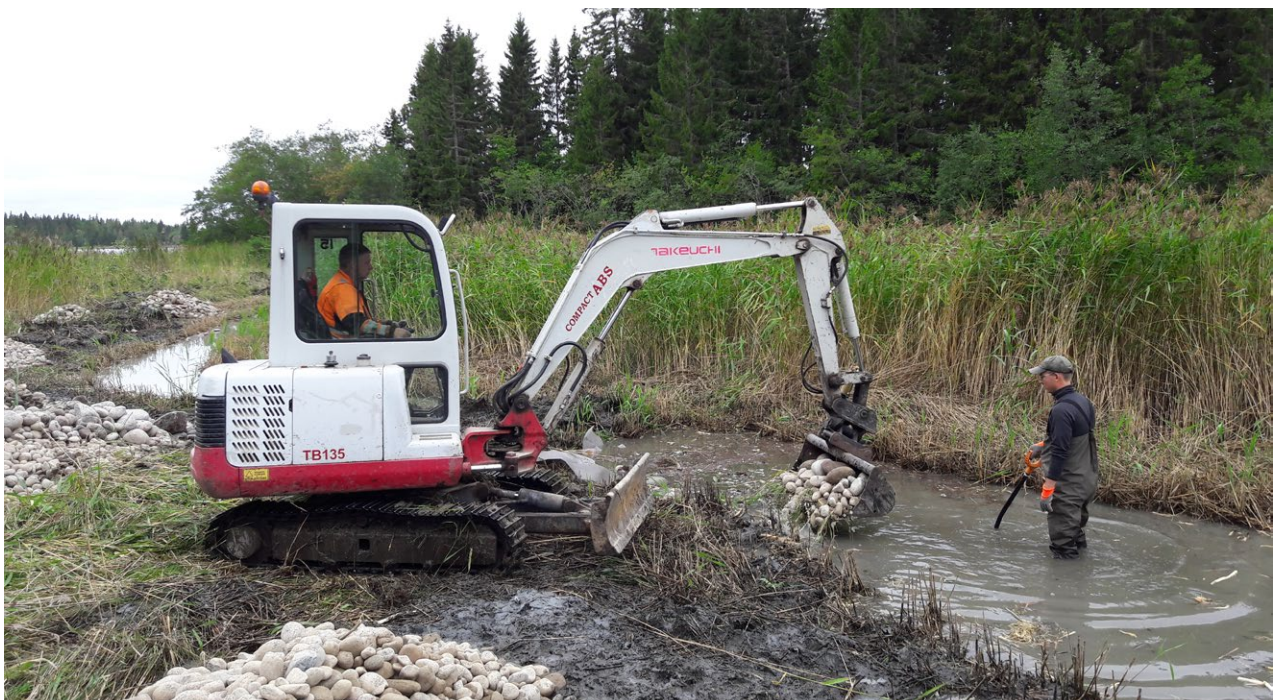
Figure 38. Stones are laid on the bottom of the channel to prevent rapid recolonisation by reeds. Photo: Sanna Kuningas/Natural Resources Institute Finland.

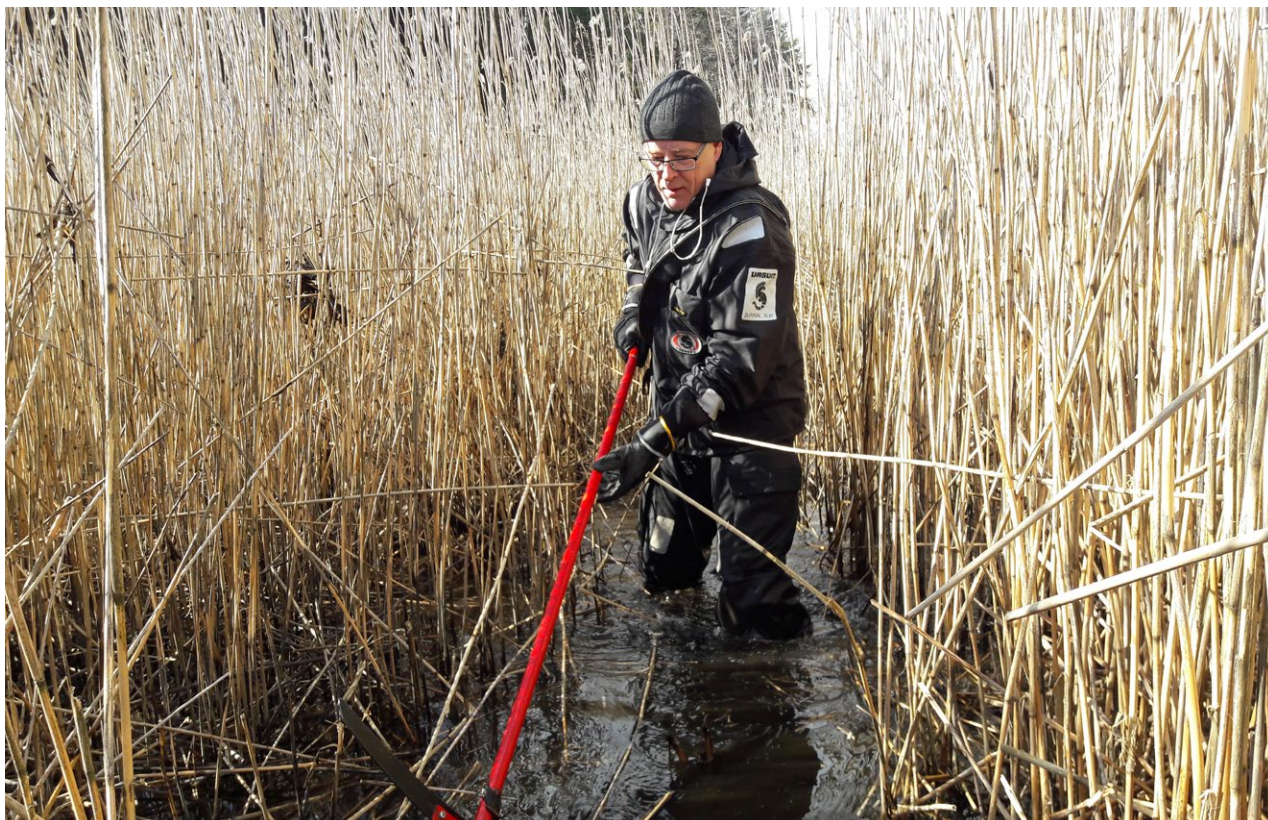
Figure 39. The channel leading to the flad is mowed with a scythe. Photo: Sanna Kuningas/Natural Resources Institute Finland.

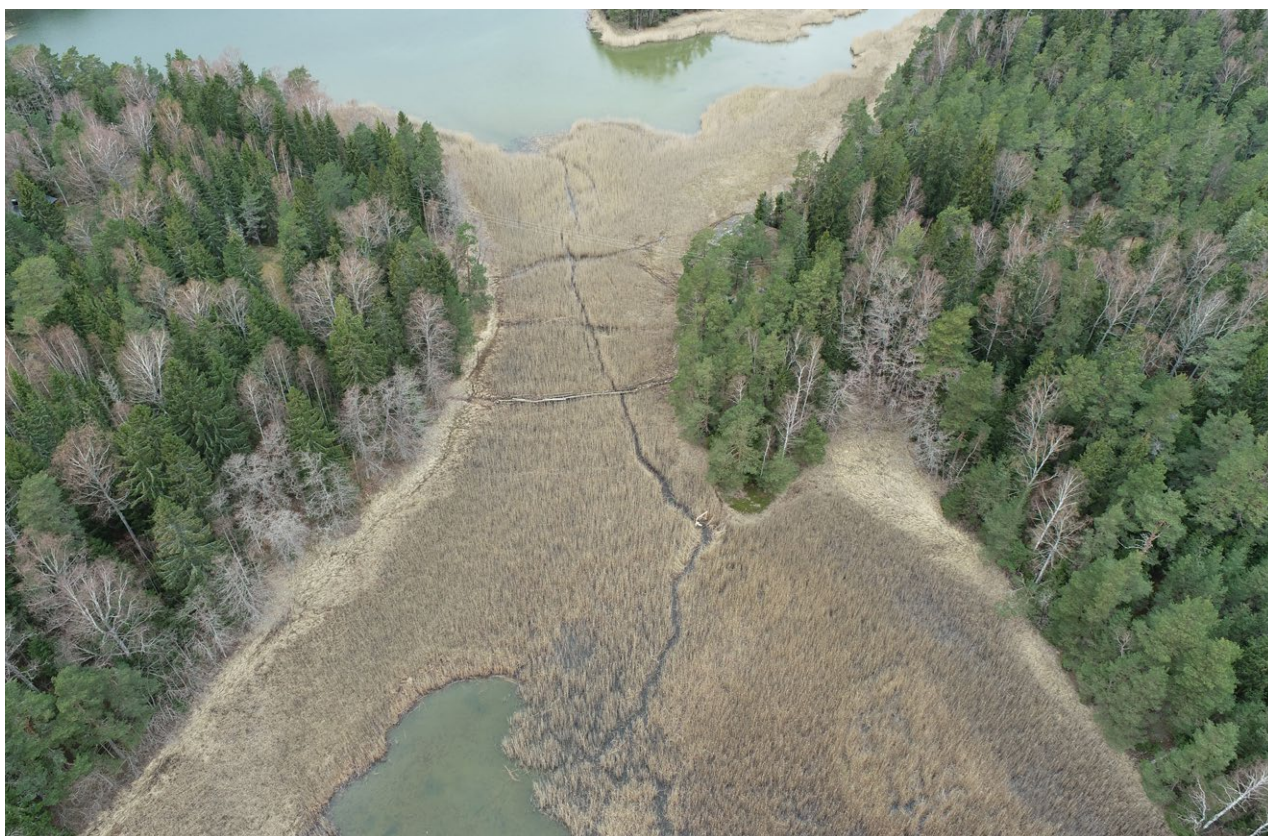
Figure 40. After manual mowing, the channel between the flad and the sea is visible in the reed bed. Photo: Sanna Kuningas/Natural Resources Institute Finland.

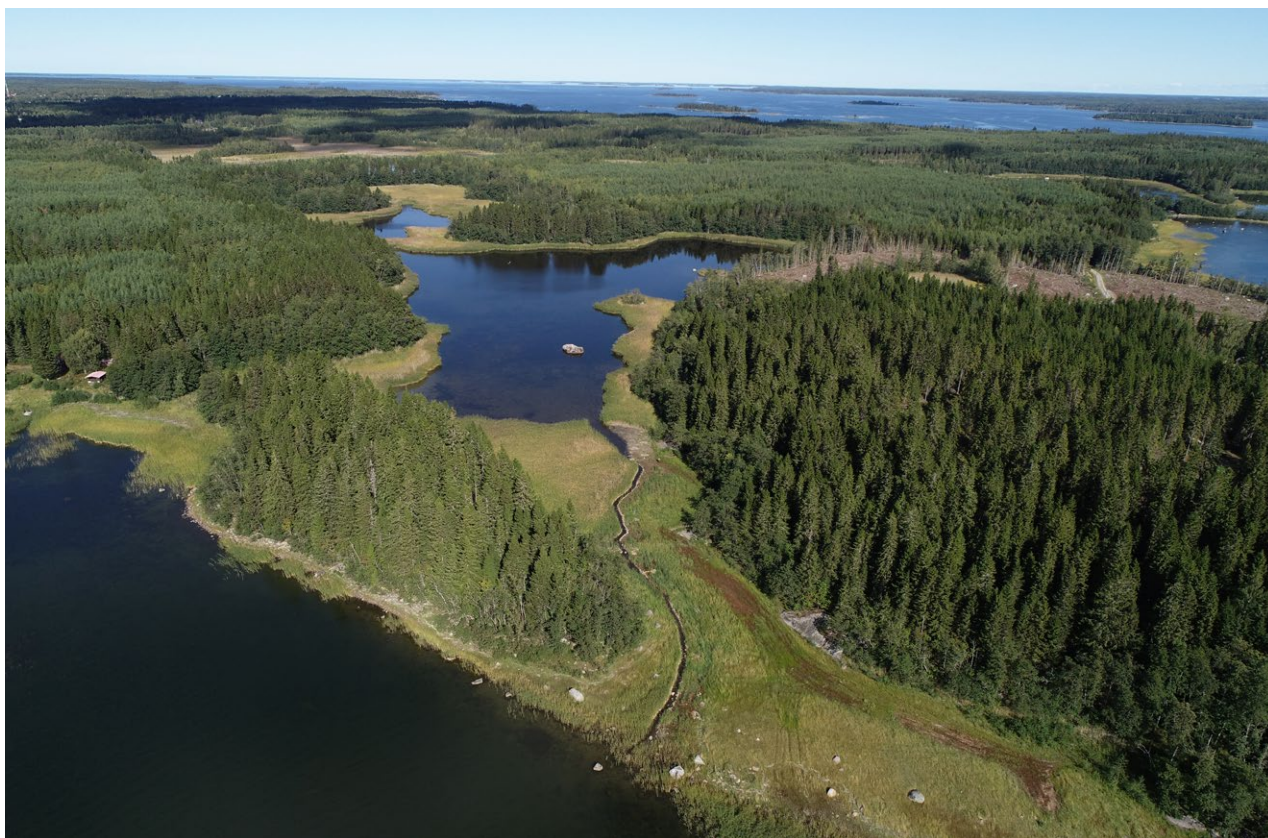
Figure 41. Backfladan and its restored channel after clearing of reeds. Photo: Lari Veneranta/Natural Resources Institute Finland.

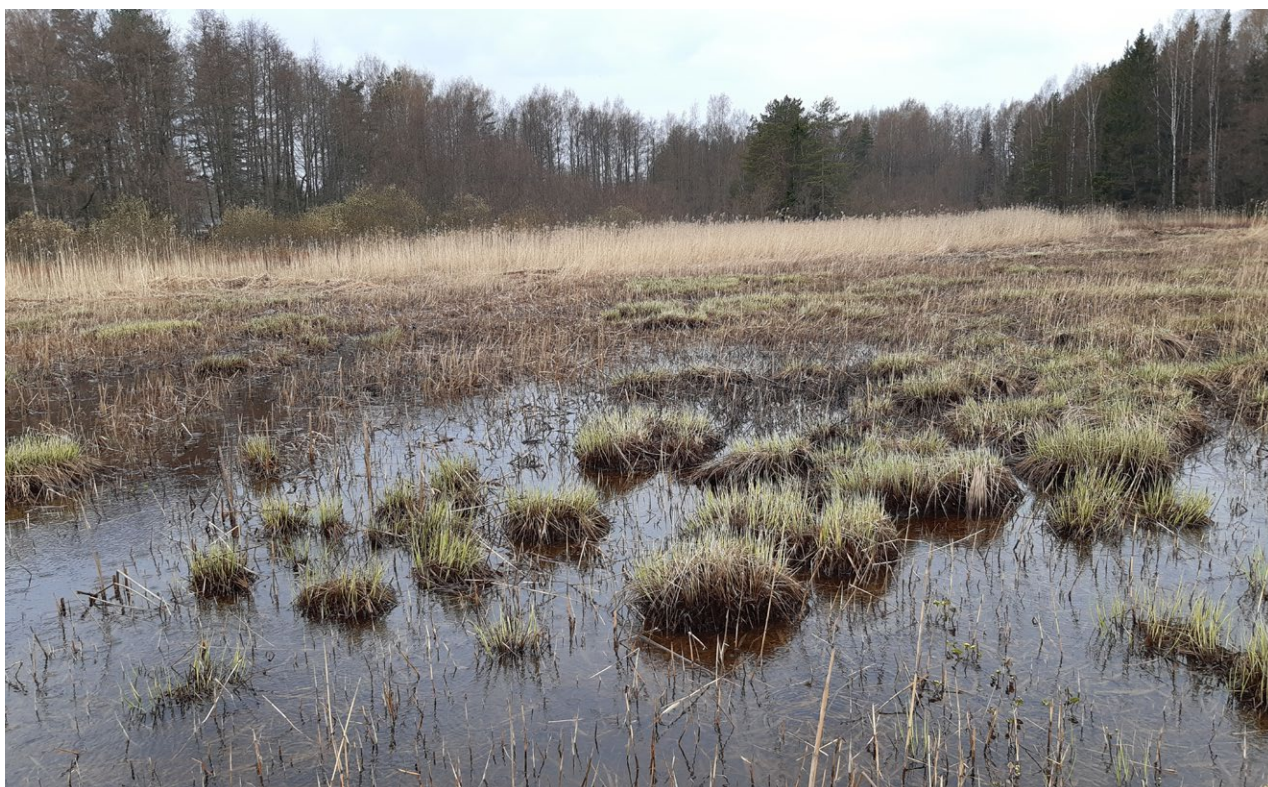
Figure 42. Pike wetland in Mussalo, Kotka. Photo: Sanna Kuningas/Natural Resources Institute Finland.

In Finland, the Finnish Federation for Recreational Fishing (SVK) has restored a few wetlands known as 'pike factories' in recent years, both on the coast and in inland waters (Figure 42). The Natural Resources Institute Finland has investigated the effectiveness of restoration at a few coastal sites. As part of its Rankku project, WWF Finland restored a wetland whose primary purpose is to reduce nutrient loading in the sea, but it is also hoped to positively impact pike reproduction. In the Åland Islands, the City of Mariehamn created an urban wetland in the Nabben area, including a small pike spawning wetland. Wetlands have also been restored in the Svibyviken area in Åland.

Migration channels have been restored, and possible barriers to migration removed in pike wetlands. Regulating dams may also have been installed to ensure sufficient water levels in the vegetation zone during pike reproduction. A suitable bottom weir may be an alternative for a regulating dam if necessary. In some places, aquatic vegetation has been

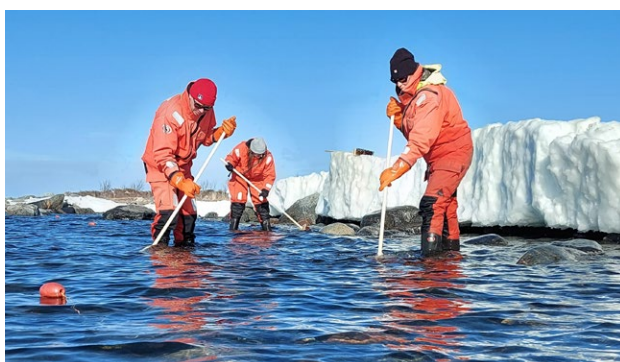
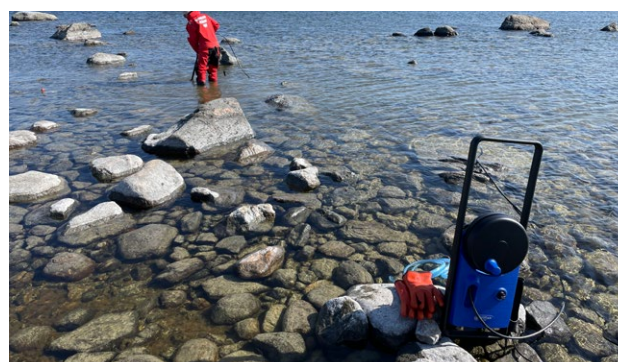
Figure 44 and 45. Brushes and a pressure washer were used to restore spawning grounds for the sea-spawning grayling. Photos: Anette Bäck/Metsähallitus.

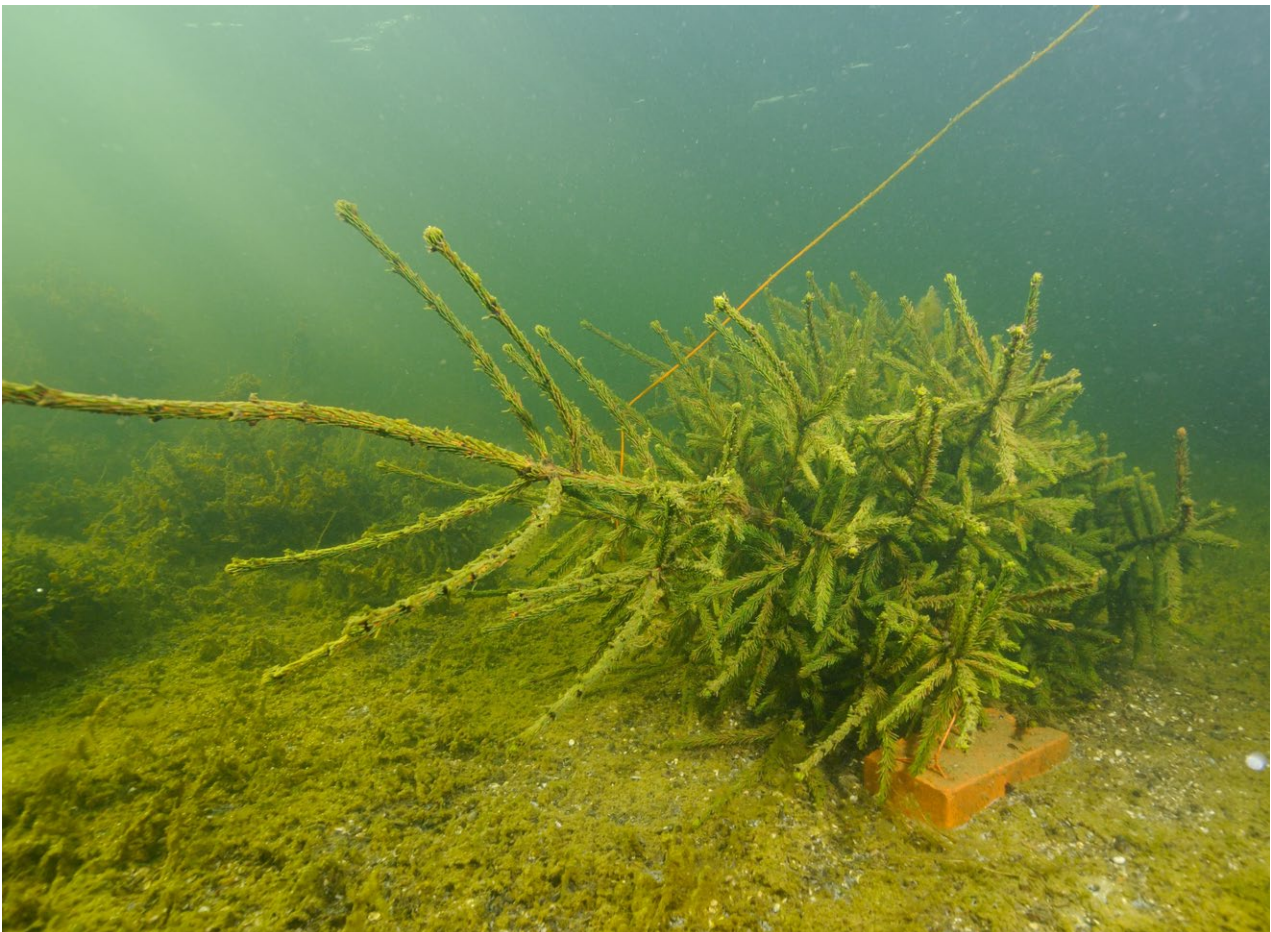
Figure 48. Introduced spawning substrates are used to increase the success of perch and pike-perch reproduction. Conifer branches provide a substrate for perch egg ribbons. Photo: Mats Westerbom.

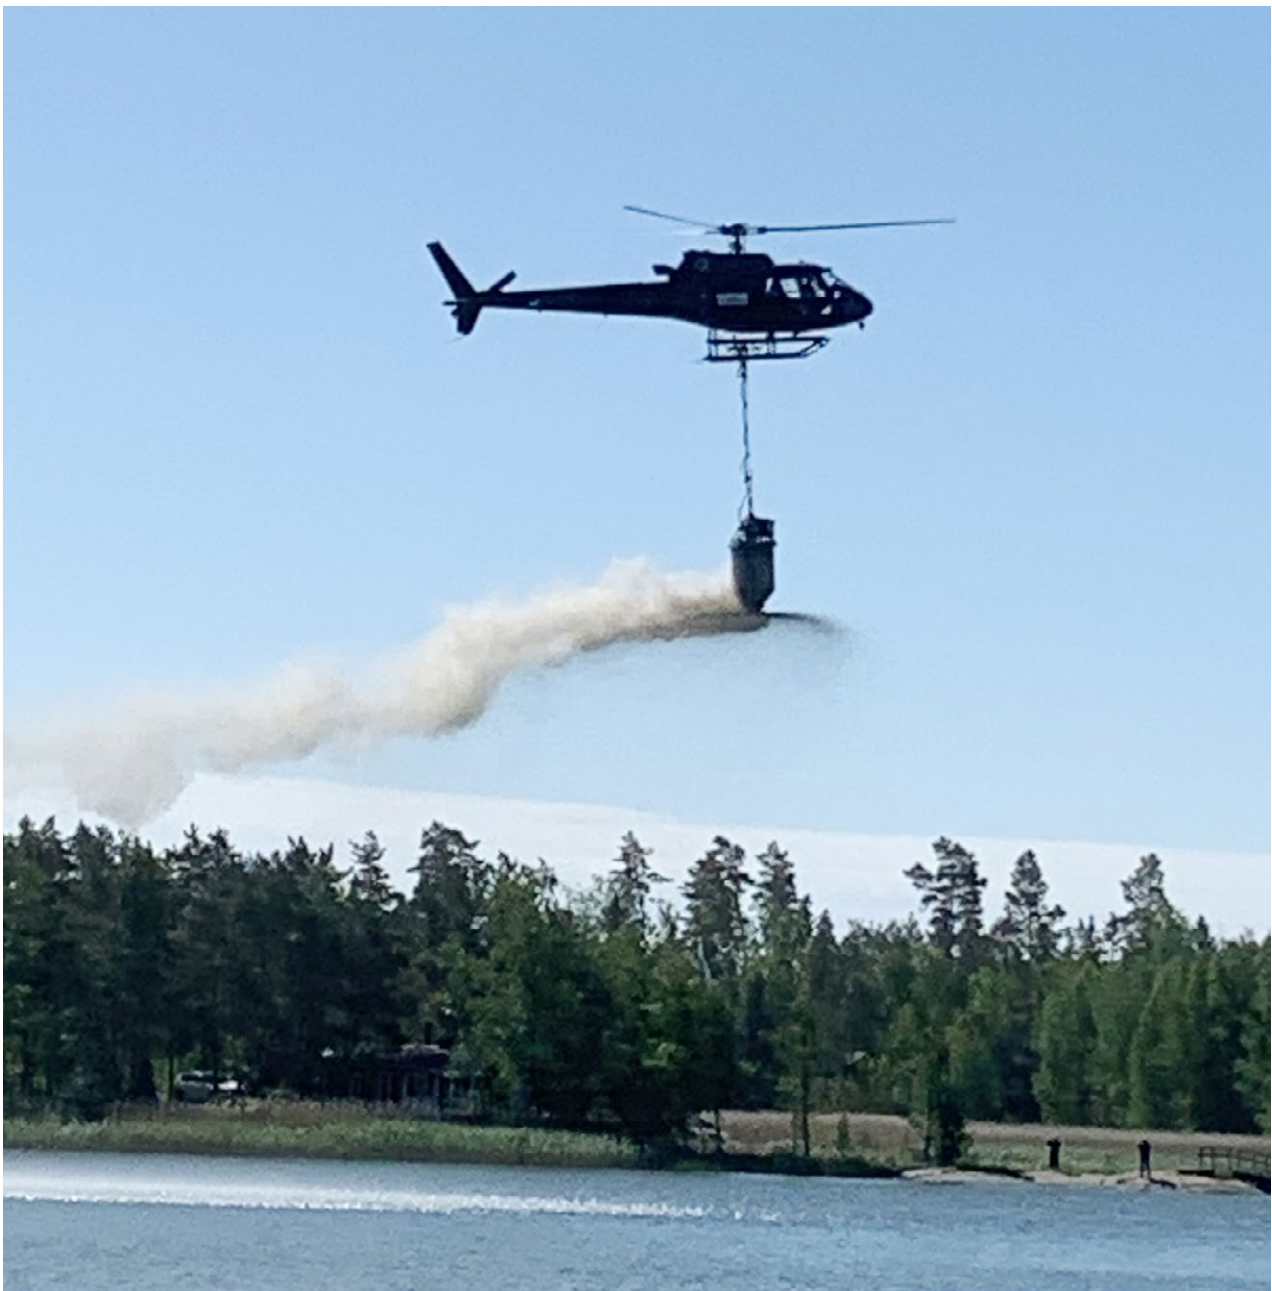
Figure 49. Application of marl in Kolkka, Rymättylä in 2020. Photo: Irma Puttonen/Åbo Akademi.

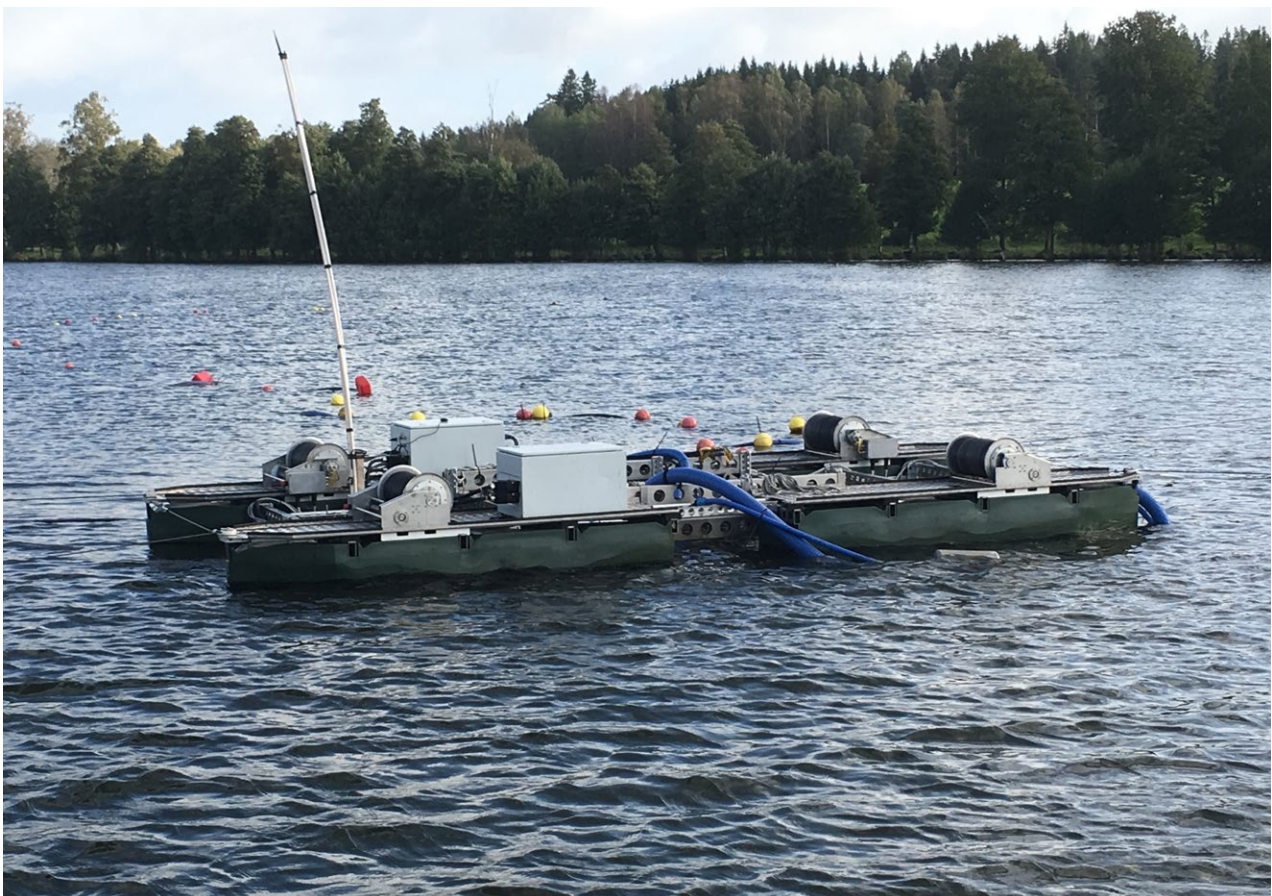
Figure 50. Sediment removal in Jönköping, Sweden (Barnarpasjön) 2018 with low-flow suction dredging equipment. Photo: Irma Puttonen/Åbo Akademi.
